Galvanic Isolator Gi50/16/SA (After 16/12/2016)

Instruction Leaflet

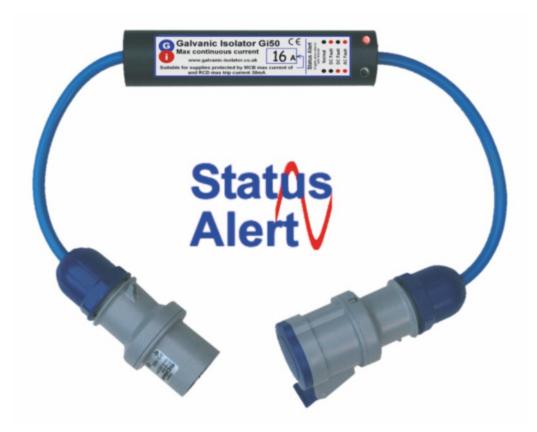
To prevent water ingress, before

installation, and periodically, check Gland Nuts on both ends for tightness (Blue in photo). They should be as tight as possible USING HAND FORCE ONLY.

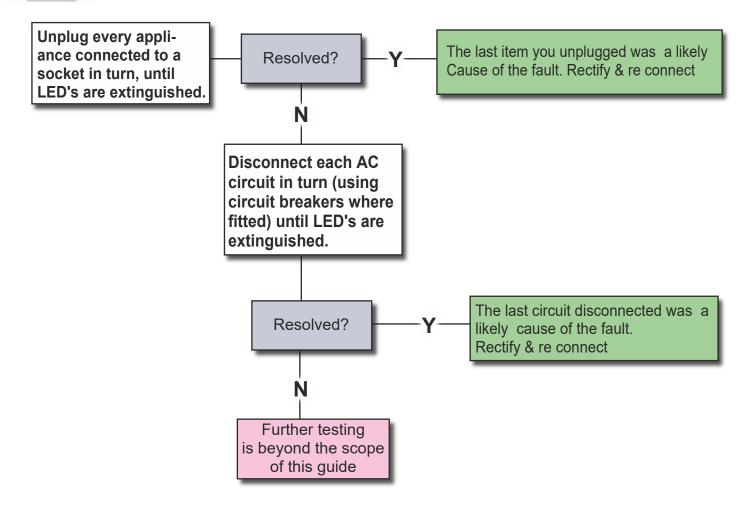
BOTH LEDs glowing

This indicates a possibility of AC (mains voltage) leakage. Proceed with great care Danger of electrical shock. If in doubt, please consult a qualified electrician.

Both Lights ON: If both lights are ON, this indicates AC leakage, usually from the mains wiring or a connected appliance. AC leakage can be a danger to life. Please see instructions for help in rectifying the problem.

If both lights are illuminated on your galvanic isolator, you have AC earth leakage. **You do NOT have a faulty isolator**. In fact, your isolator is alerting you to a potentially dangerous situation that you may not previously have been aware of.
