Galvanic Isolator

Gi120-P-SA

Instruction Leaflet

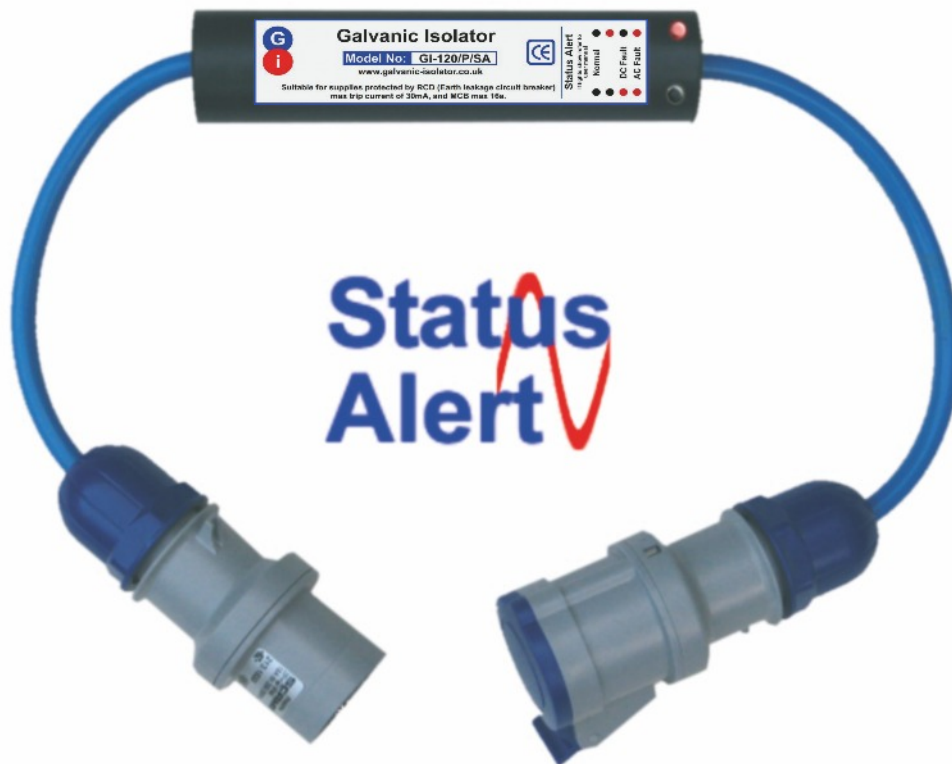
To prevent water ingress, before installation, and periodically, check Gland Nuts on both ends for tightness (Blue in photo). They should be as tight as possible **USING HAND FORCE ONLY**.

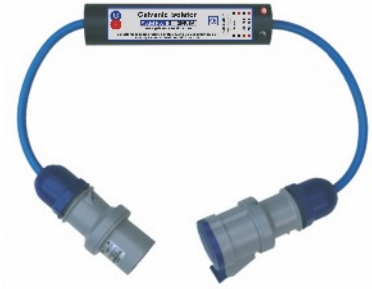
The Galvanic Isolator simply connects to EITHER end of your shore line. It can be connected either at the boat end or the shore end. Both options work equally well. Ensure that no ground connections on the vessel bypass the Galvanic isolator.

- 1) Switch off the electricity supply at the shore supply.
- 2) Unplug the shore line from whichever end you choose.
- 3) Connect the isolator to the now free end of the shore line.
- 4) Connect the free end of the isolator to the boat/shore supply.
- 5) Switch on the electricity supply at the shore supply.
- 6) Check that the RCD test button on the boat operates normally
- 7) You are now protected.

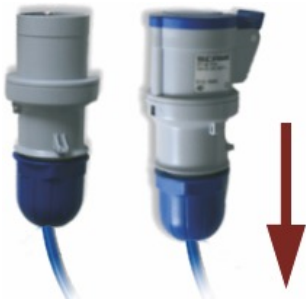
Locate your isolator where it will not be subjected to excessive heat, physical damage or water ingress, particularly the plug & socket. (Rain is acceptable - immersed or in running water is not).

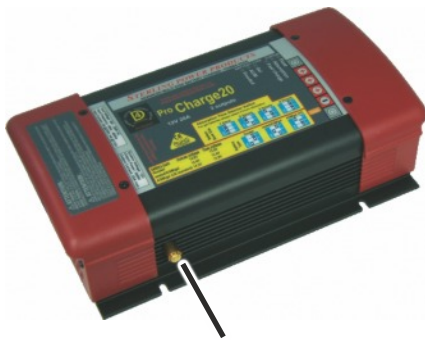
Earth bonding point

Pay close attention to earthing of equipment. Equipment is often installed without adequate earth bonding. Please consult the equipment's installation manual, or contact the manufacturers for more information.

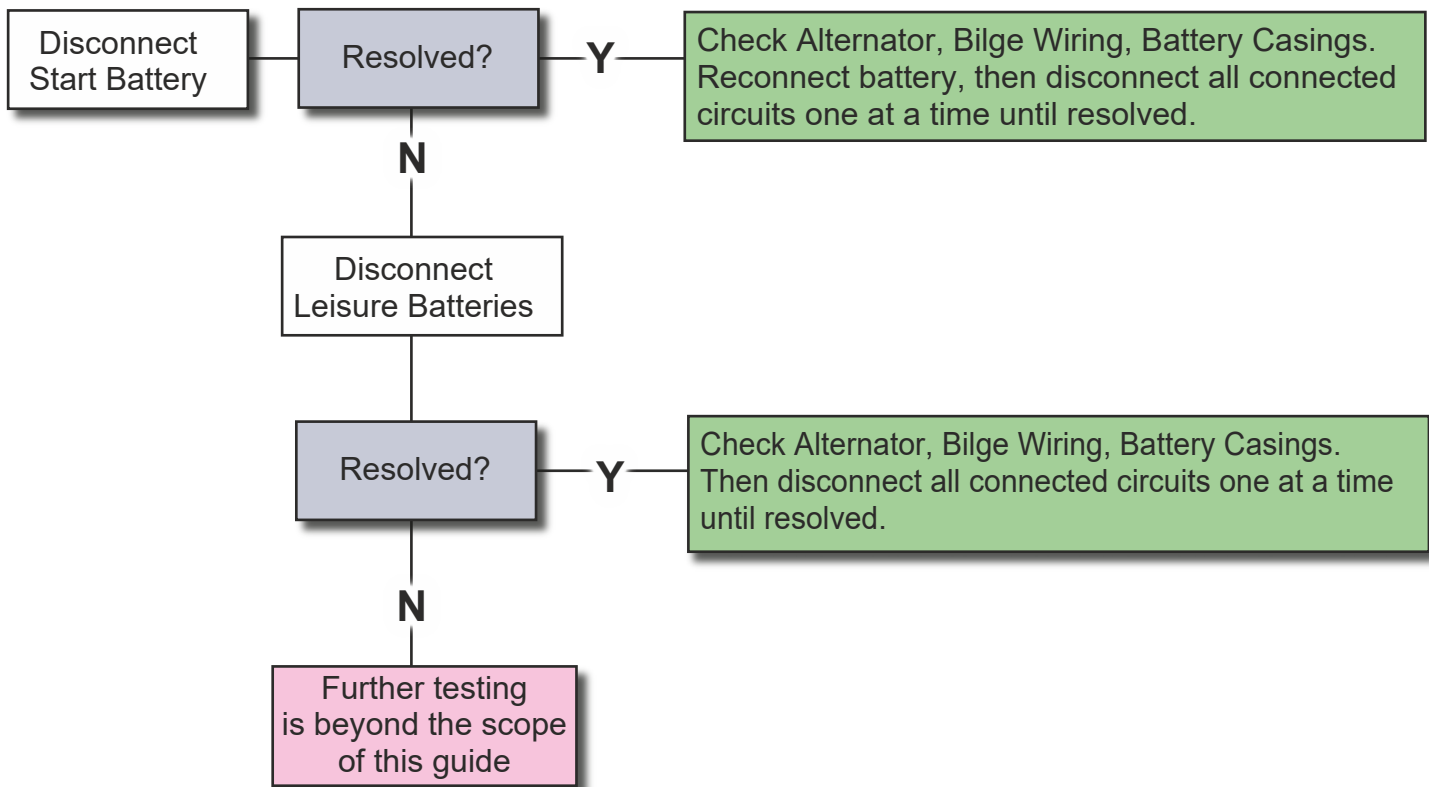
ONE (either) LED glowing

One Light ON: If either of the lights are on, it indicates DC leakage. This can cause severe corrosion to your boat. Our instructions give clear basic advice on how to resolve the problem.

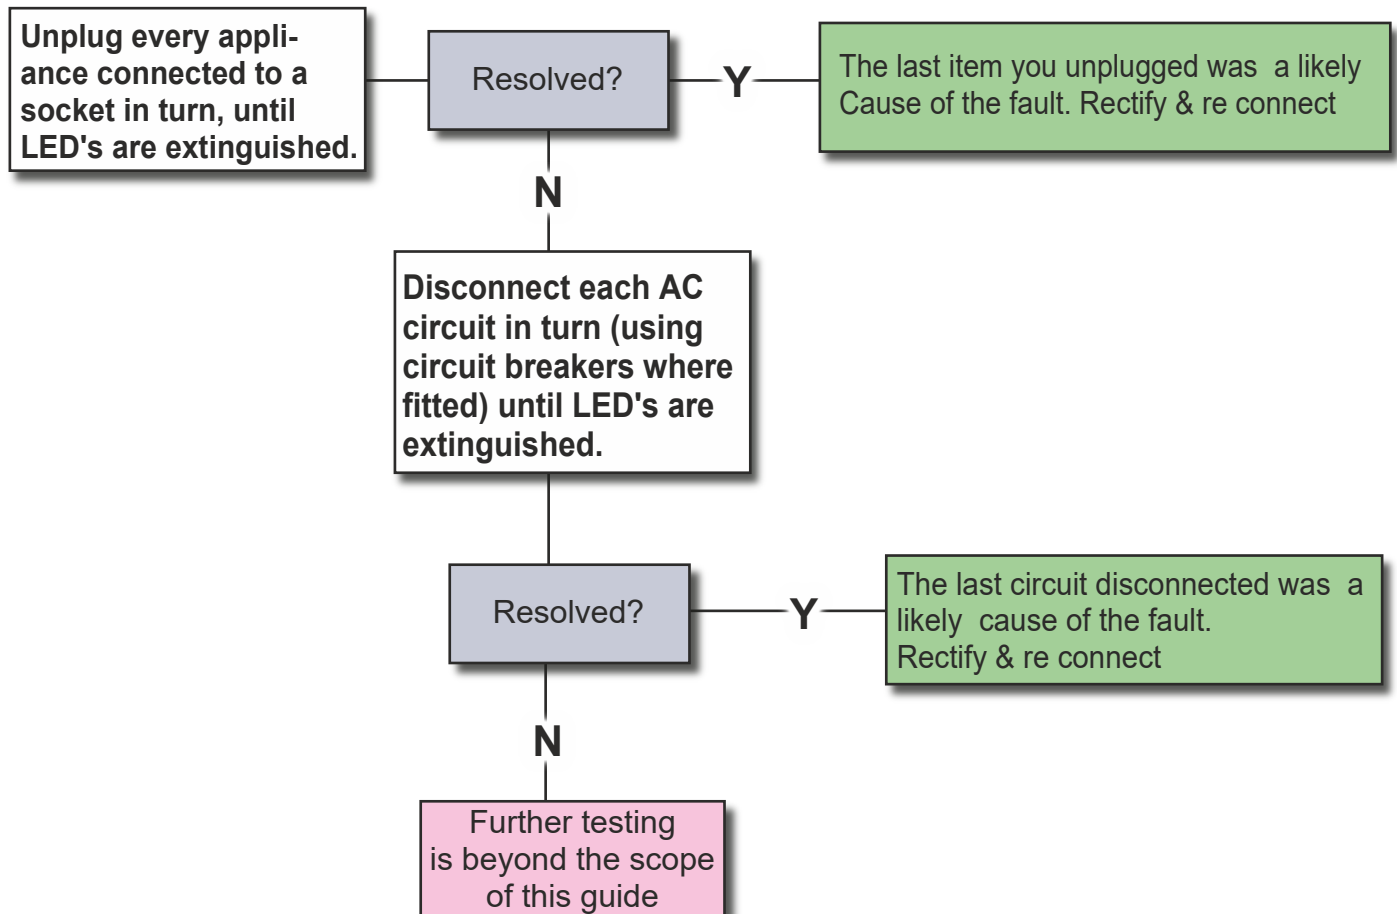
BOTH LEDs glowing

This indicates a possibility of AC (mains voltage) leakage. Proceed with great care. Danger of electrical shock. If in doubt, please consult a qualified electrician.

Both Lights ON: If both lights are ON, this indicates AC leakage, usually from the mains wiring or a connected appliance. AC leakage can be a danger to life. Please see instructions for help in rectifying the problem.
