## Galvanic Isolator Gi50/16/SA

# **Instruction Leaflet**

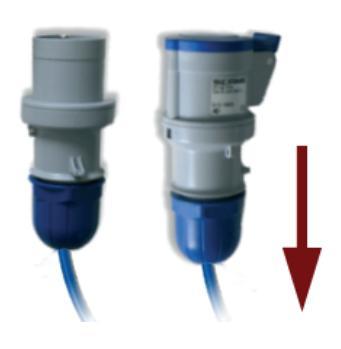
The Galvanic Isolator simply connects to EITHER end of your shore line. It can be connected either at the boat end or the shore end. Both options work equally well.

When installed, to avoid water ingress, we strongly advise that the cable entries to the plug & socket should point downwards

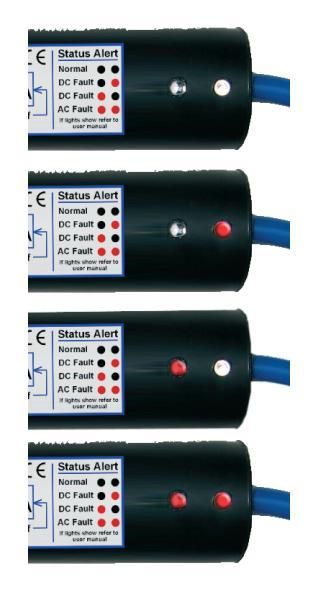
IDEALLY, the lights will be as below.

Both Lights OFF: Normal operation. No action required – just check back occasionally to ensure that all's well.

**One Light ON:** If either of the lights are on, it indicates DC leakage. This can cause severe corrosion to your boat. Our instructions give clear basic advice on how to resolve the problem.

Both Lights ON: If both lights are ON, this indicates AC leakage, usually from the mains wiring or a connected appliance. AC leakage can be a danger to life. Please see instructions for help in rectifying the problem.

The LED's on your isolator inform you about any faults with your boats Earthing arrangement. Illuminated LED's <u>NEVER</u> indicate a faulty isolator.

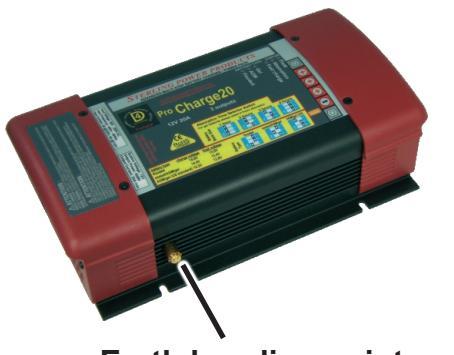
Earth bonding point

Pay close attention to earthing of equipment. Equipment is often installed without adequate earth bonding. Please consult the equipment's installation manual, or contact the manufacturers for more information.

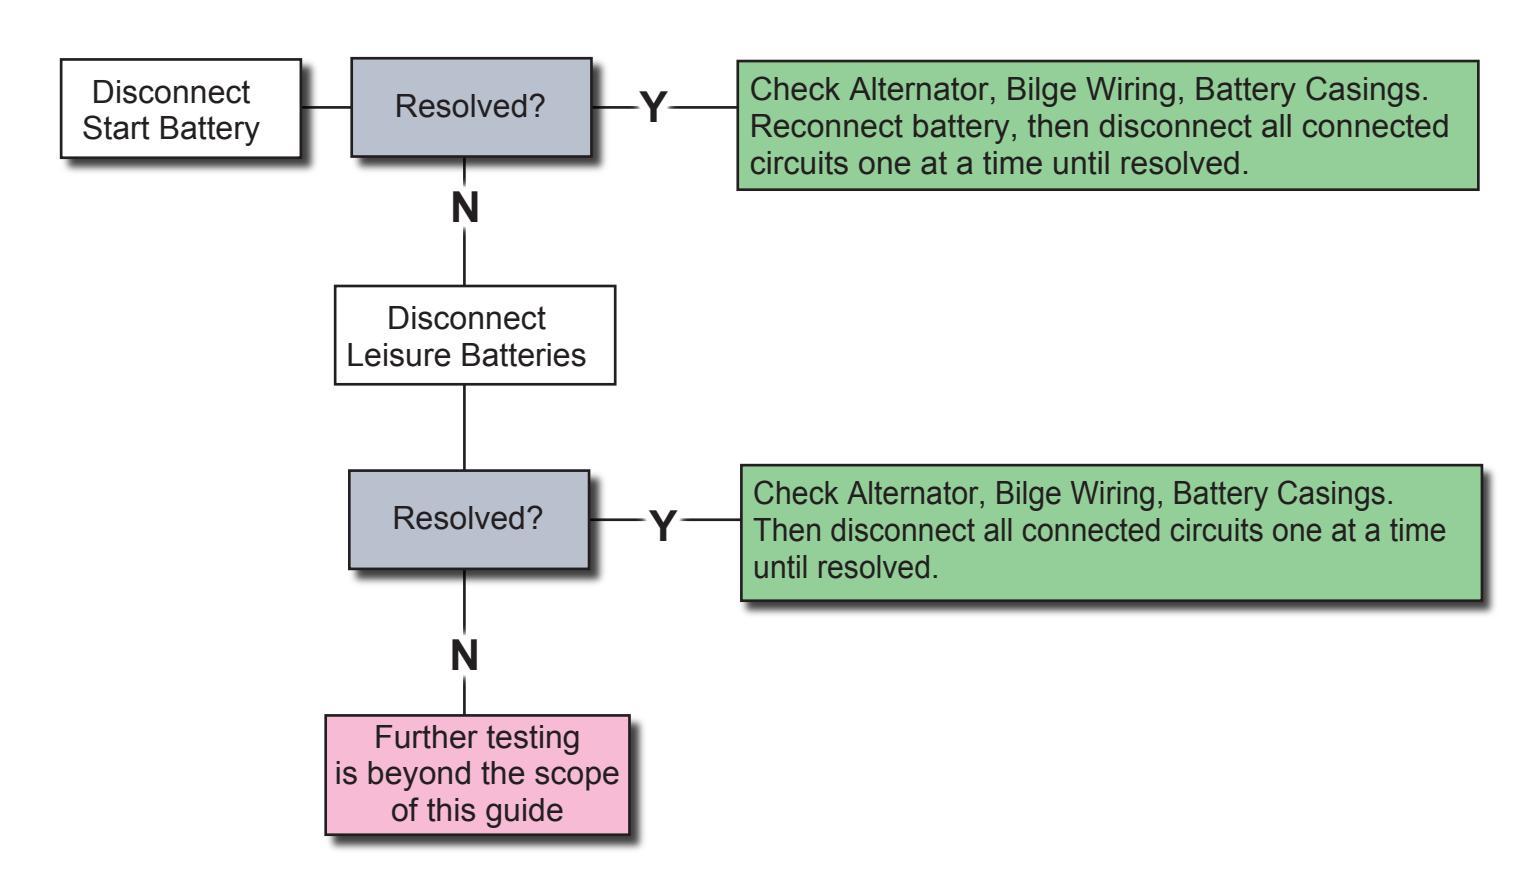
#### **ONE** (either) LED glowing

Increased brightness of either LED indicates DC leakage.

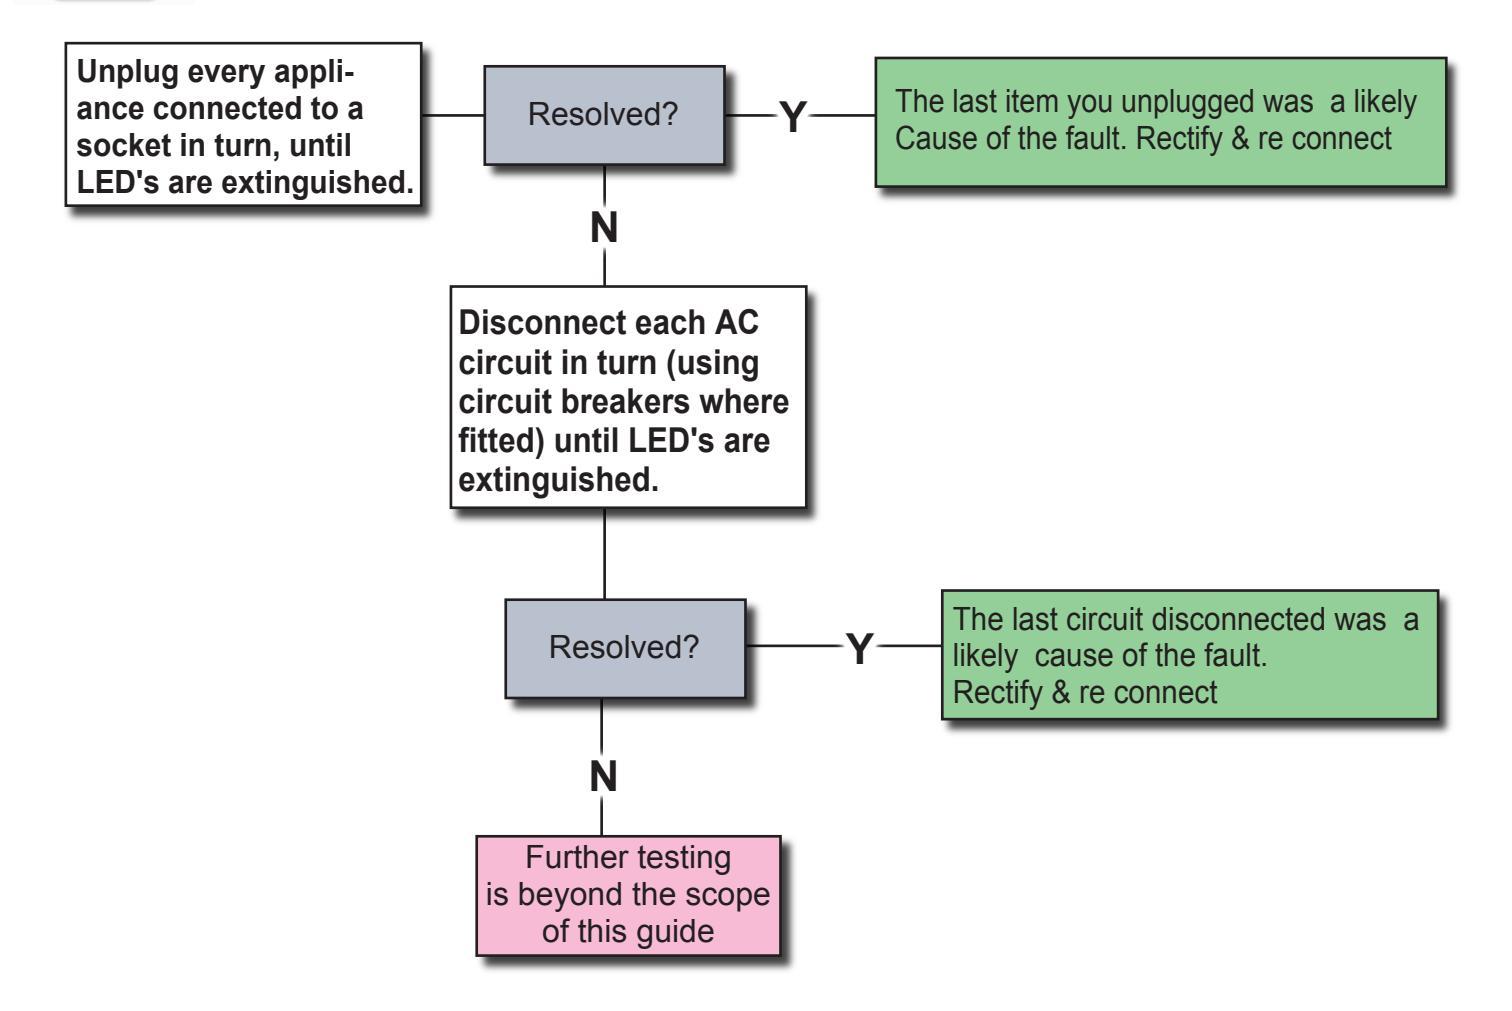
#### **BOTH LEDs glowing**

This indicates a possibility of AC (mains voltage) leakage. Proceed with great care Danger of electrical shock. If in doubt, please consult a qualified electrician.

If both lights are illuminated on your galvanic isolator, you have AC earth leakage. **You do NOT have a faulty isolator**. In fact, your isolator is alerting you to a potentially dangerous situation that you may not previously have been aware of.
