# Installation Guide

## Galvanic Isolator Gi120/S/SA

The Gi120/S/SA is designed for installations connected to shore supplies protected by an RCD with a trip current not exceeding 30mA.

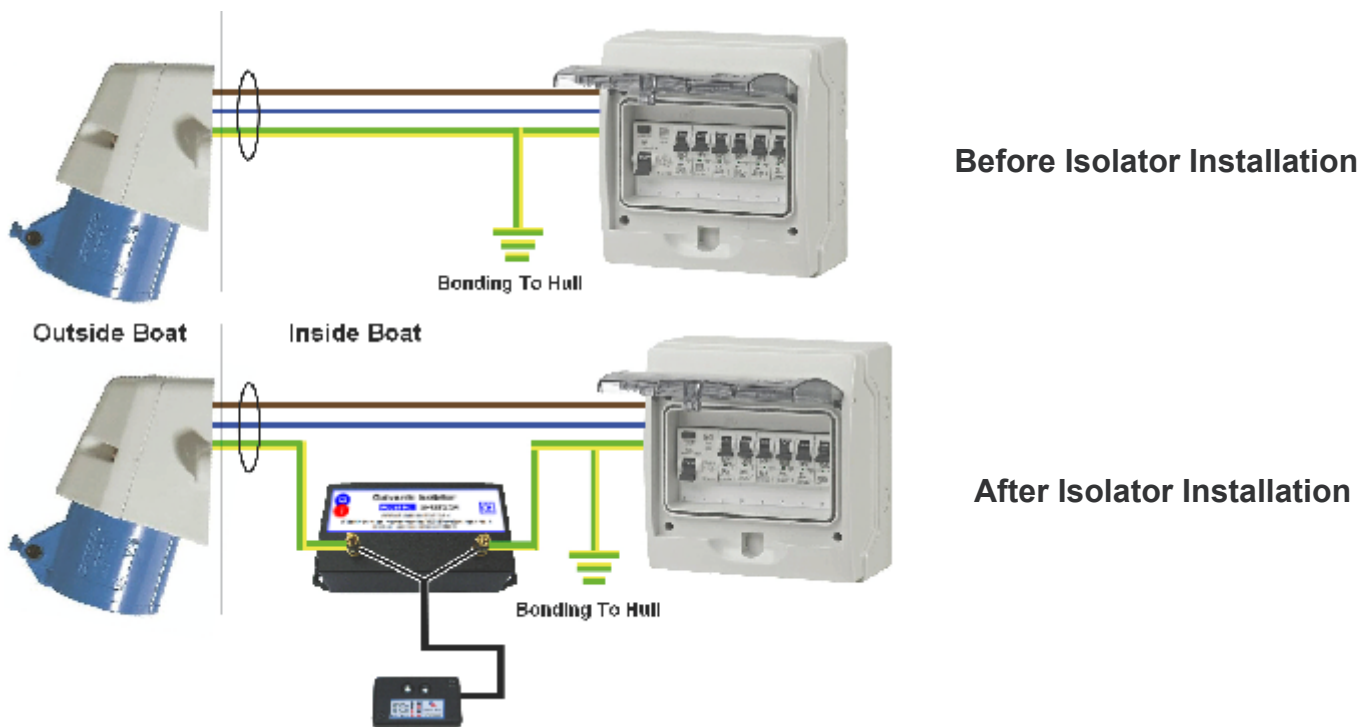
- 1) Disconnect the boat from the shore supply, and ensure that any invertors/generators etc are switched off. Please refer to the “before & after” diagram below.

- 2) Disassemble the power input connection attached to the boat, and locate the EARTH terminal. This will normally have a green or green/yellow cable connected to it. It is the LONGEST pin in the connector.

- 3) Disconnect that cable, and route it inside the boat to the place where the isolator will be located.

**(If there are several wires in the terminal, they must ALL be routed to the same place and connected to the same terminal of the isolator. This is CRUCIAL to ensure that the earth bonding is retained, and that your isolator works as intended).** Label the cable(s) so that they can be identified later.

- 4) Connect a new cable from the earth terminal of the power input connection, and route it inside the boat to the place where the isolator will be located. This cable should have a cross sectional area of at least 2.5mm<sup>2</sup>. Label the cable so it can be identified later.

- 5) Having fixed the isolator, connect the single cable to one of the terminals on the isolator (either terminal can be used).

- 6) Connect the remaining cable(s) to the other terminal of the isolator. Do not tighten yet.

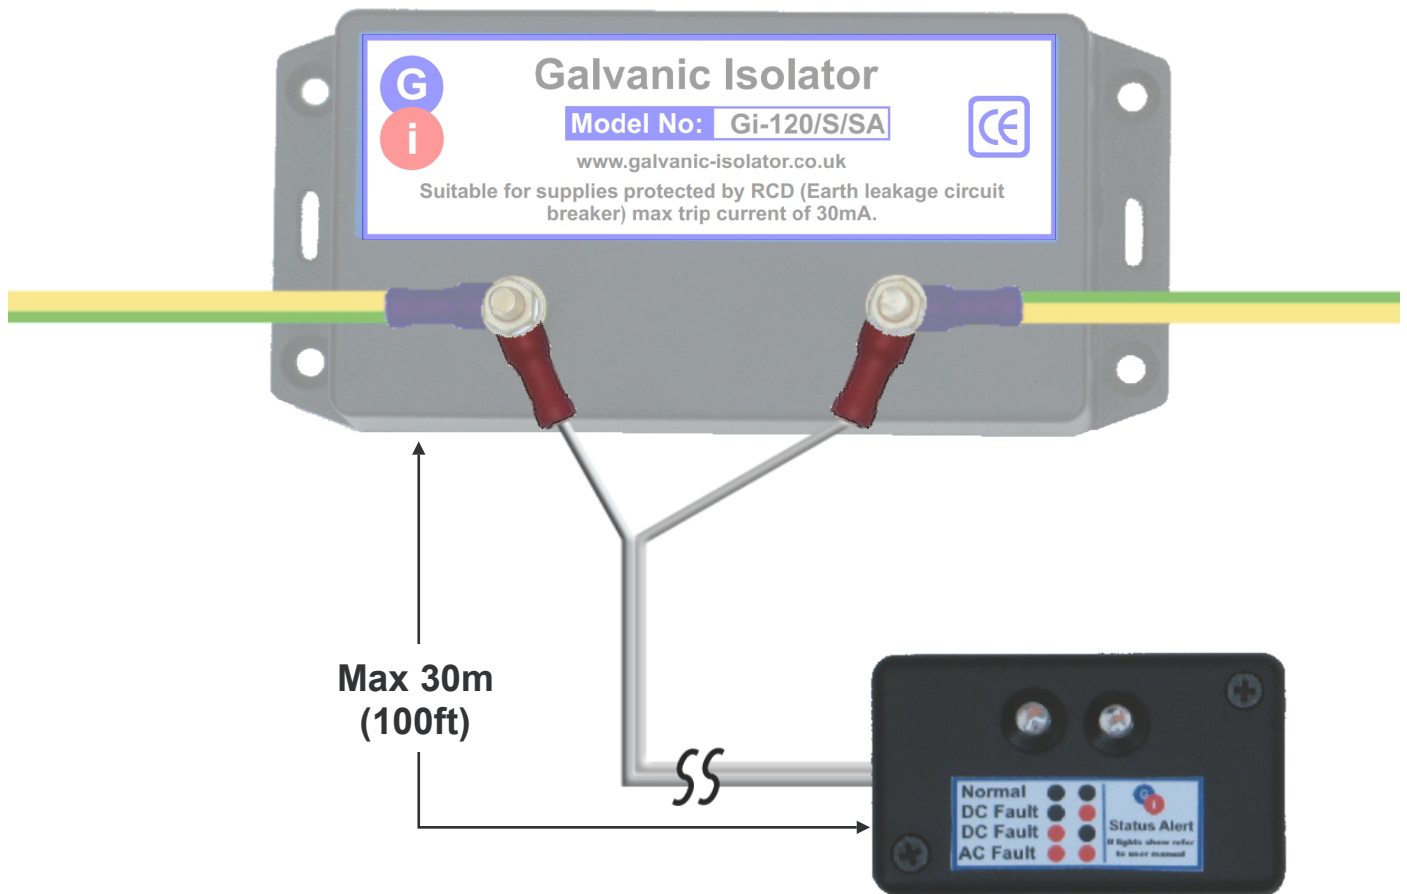
- 10) Connect the terminals on the end of the Remote Indicator connecting cable to the terminals on the Isolator.
- 11) You should now tighten the connections to the isolator, taking care not to over tighten.
- 12) The power may now be reconnected.

- 13) If any of the lights illuminate, earth leakage is present. **It is NOT a sign of a faulty isolator!** Please follow the link below and refer to the fault finding information.

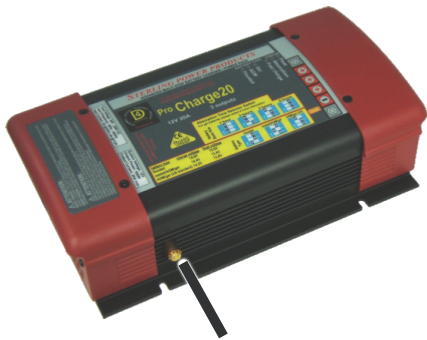
Earth bonding point

**Pay close attention to earthing of equipment. Equipment is often installed without adequate earth bonding. Please consult the equipment's installation manual, or contact the manufacturers for more information.**

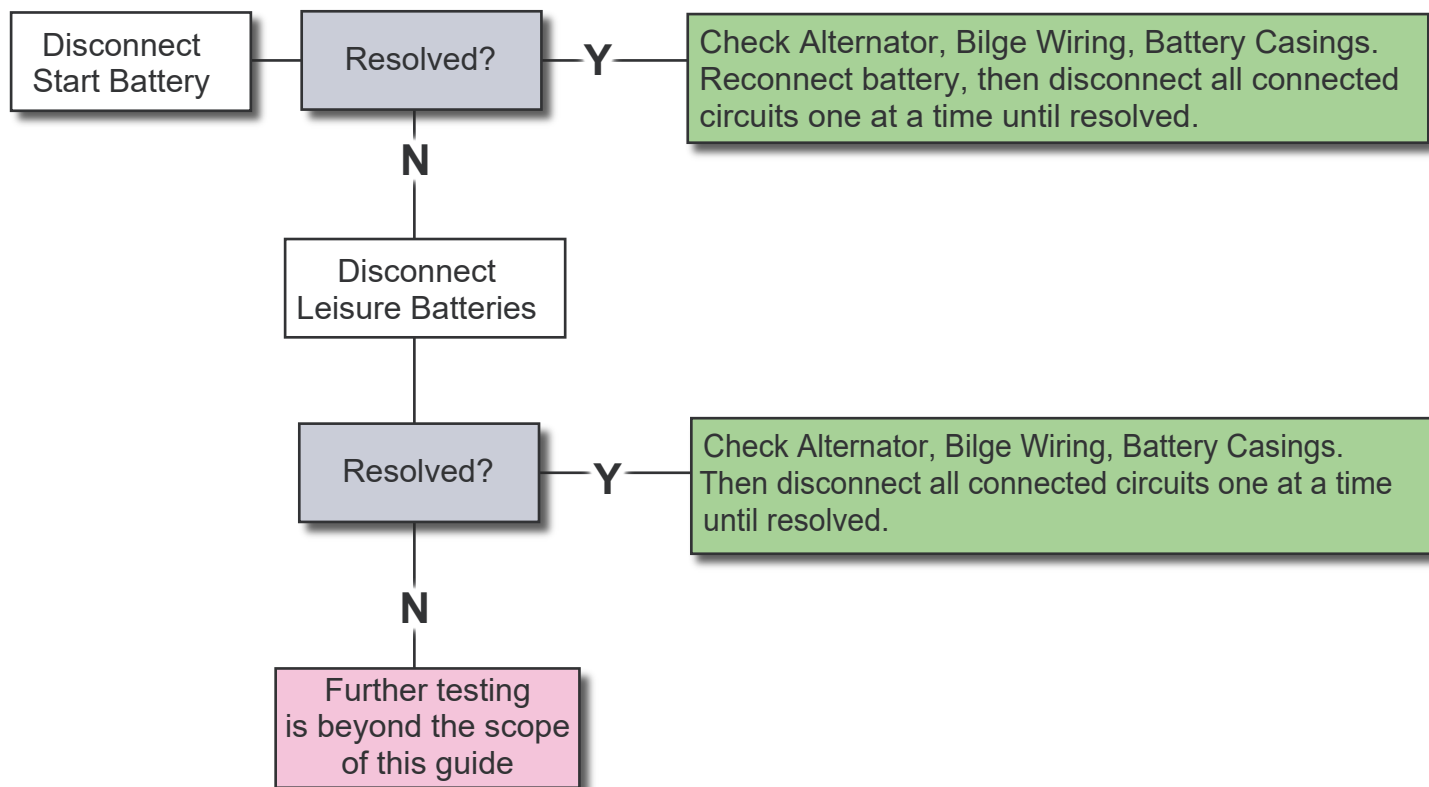
## ONE (either) LED glowing

**One Light ON:** If either of the lights are on, it indicates DC leakage. This can cause severe corrosion to your boat. Our instructions give clear basic advice on how to resolve the problem.

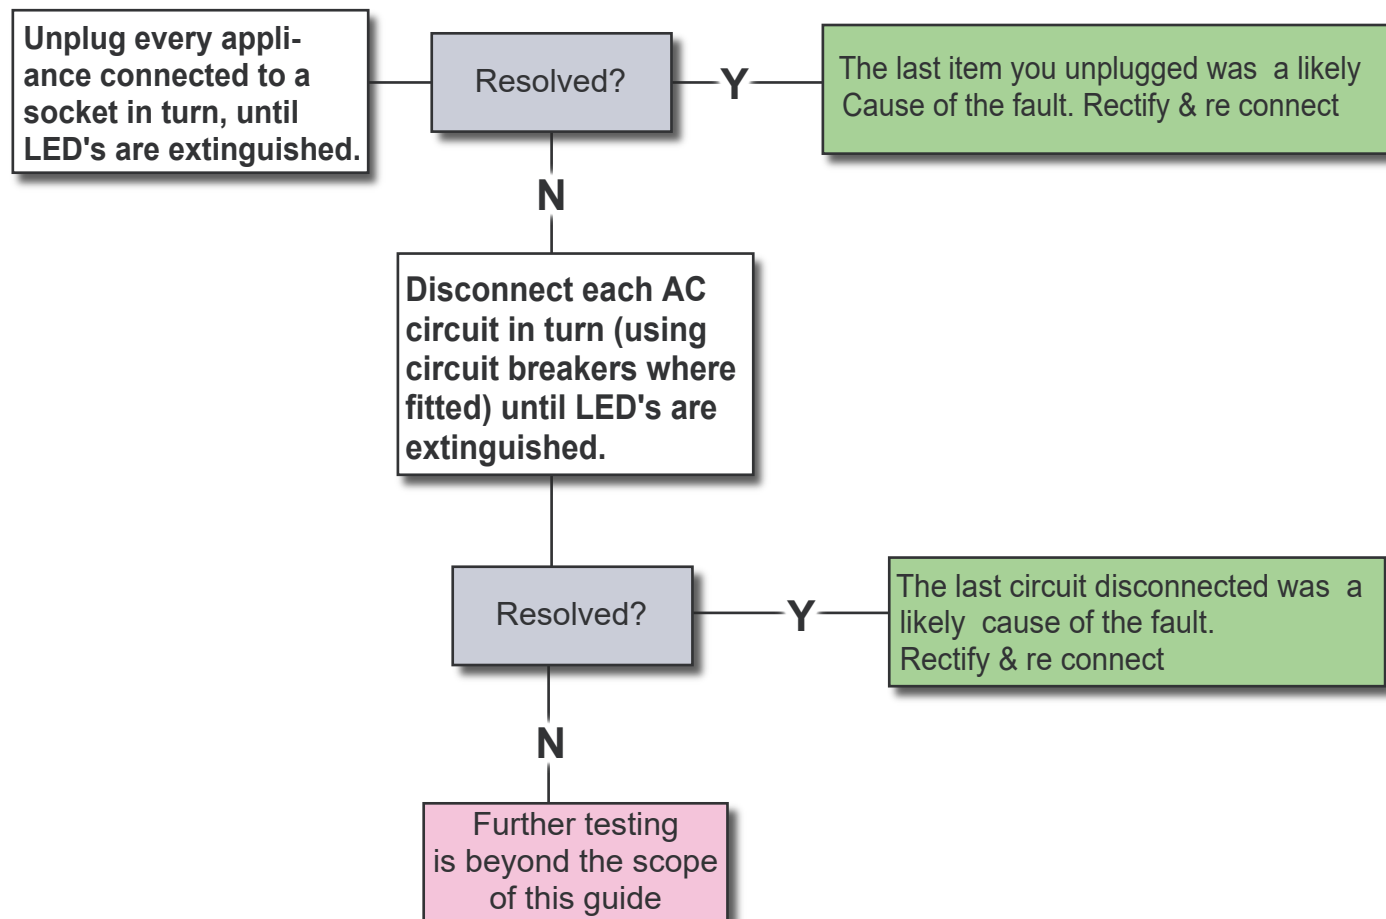
## BOTH LEDs glowing

**This indicates a possibility of AC (mains voltage) leakage. Proceed with great care. Danger of electrical shock. If in doubt, please consult a qualified electrician.**

**Both Lights ON:** If both lights are ON, this indicates AC leakage, usually from the mains wiring or a connected appliance. AC leakage can be a danger to life. Please see instructions for help in rectifying the problem.
