Galvanic Isolator

Gi120-P-SA

Instruction Leaflet

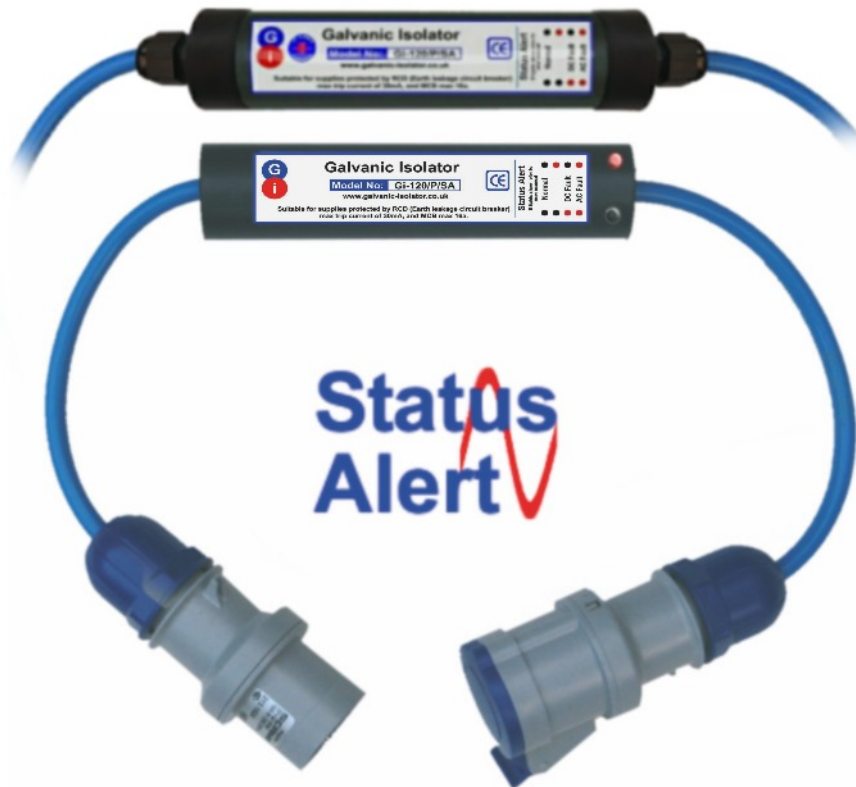
To prevent water ingress, before installation, and periodically, check Gland Nuts on both ends for tightness (Blue in photo). They should be as tight as possible **USING HAND FORCE ONLY**.

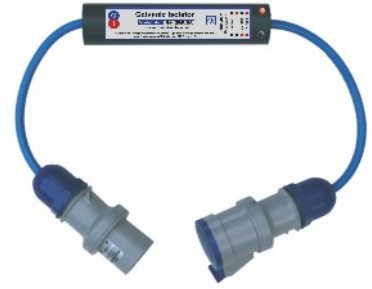
The Galvanic Isolator simply connects to EITHER end of your shore line. It can be connected either at the boat end or the shore end. Both options work equally well. Ensure that no ground connections on the vessel bypass the Galvanic isolator.

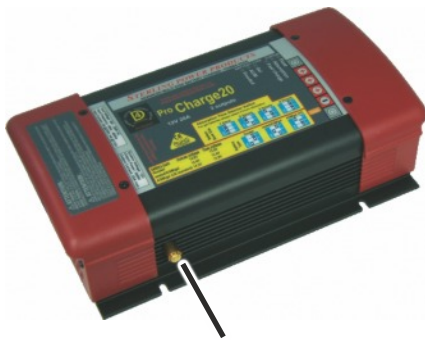
Earth bonding point

Pay close attention to earthing of equipment. Equipment is often installed without adequate earth bonding. Please consult the equipment's installation manual, or contact the manufacturers for more information.
