Installation Guide

Galvanic Isolator Gi120/S/XPT

Galvanic Isolator

Instruction Leaflet

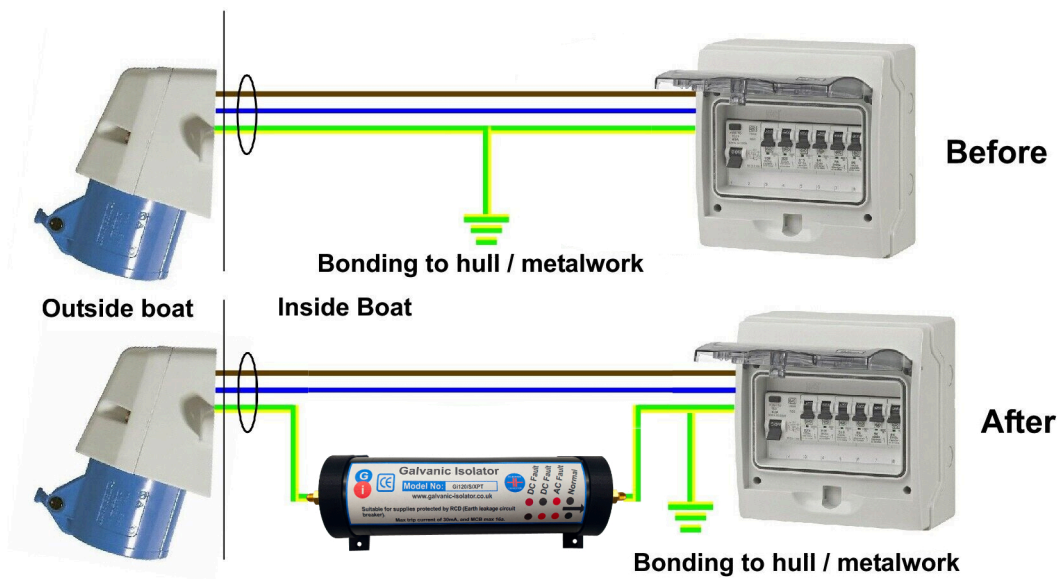
1) Disconnect the boat from the shore supply, and ensure that any invertors/generators etc are switched off. Please refer to the “before & after” diagram below.

2) Disassemble the power input connection attached to the boat, and locate the EARTH terminal. This will normally have a green or green/yellow cable connected to it. It is the LONGEST pin in the connector.

3) Disconnect that cable, and route it inside the boat to the place where the isolator will be located.

(If there are several wires in the terminal, they must ALL be routed to the same place and connected to the same terminal of the isolator. This is CRUCIAL to ensure that the earth bonding is retained, and that your isolator works as intended). Label the cable(s) so that they can be identified later.

4) Connect a new cable from the earth terminal of the power input connection, and route it inside the boat to the place where the isolator will be located. This cable should have a minimum cross-sectional area 2.5mm^2 .

5) Having fixed the isolator, connect the single cable to one of the terminals on the isolator (either terminal can be used).

6) Connect the remaining cable(s) to the other terminal of the isolator. Do not tighten yet.

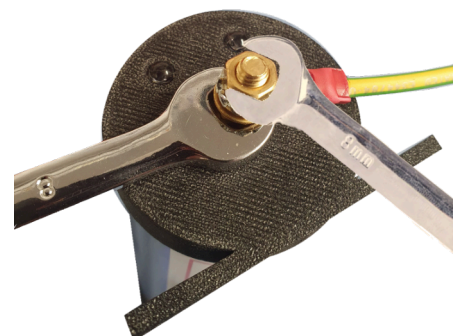
8) Tighten the connections to the isolator, taking care not to over-tighten. **Use a spanner to hold the lower nut whilst tightening the upper nut** (See Picture).

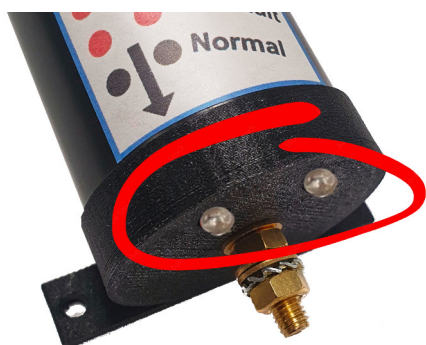
The LED's on your isolator inform you about any faults with your boats earthing system.

Illuminated LED's NEVER indicate a faulty isolator.

BOTH LED's should normally be OFF. The lights ONLY come On in the event of a problem.

Both Lights OFF: Normal operation. No action required – just check back occasionally to ensure that all's well.

One Light ON: If either of the lights are on, it indicates DC leakage. This can cause severe corrosion to your boat. Our instructions give clear basic advice on how to resolve the problem.

Both Lights ON: If both lights are ON, this indicates AC leakage, usually from the mains wiring or a connected appliance. AC leakage can be a danger to life. Please see instructions for help in rectifying the problem.

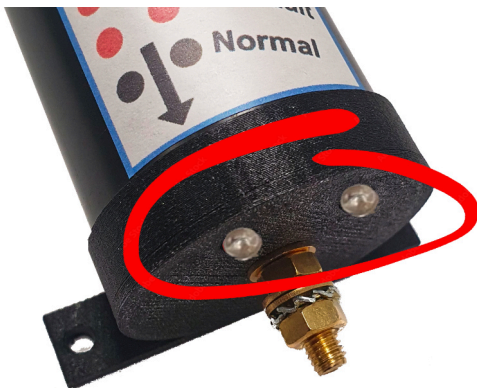
The LED's on your isolator inform you about any faults with your boats earthing system.

Illuminated LED's NEVER indicate a faulty isolator.

BOTH LED's should normally be OFF. The lights **ONLY** come On in the event of a problem.

Both Lights OFF: Normal operation. No action required – just check back occasionally to ensure that all's well.

One Light ON: If either of the lights are on, it indicates DC leakage. This can cause severe corrosion to your boat. Our instructions give clear basic advice on how to resolve the problem.

Both Lights ON: If both lights are ON, this indicates AC leakage, usually from the mains wiring or a connected appliance. AC leakage can be a danger to life. Please see instructions for help in rectifying the problem.

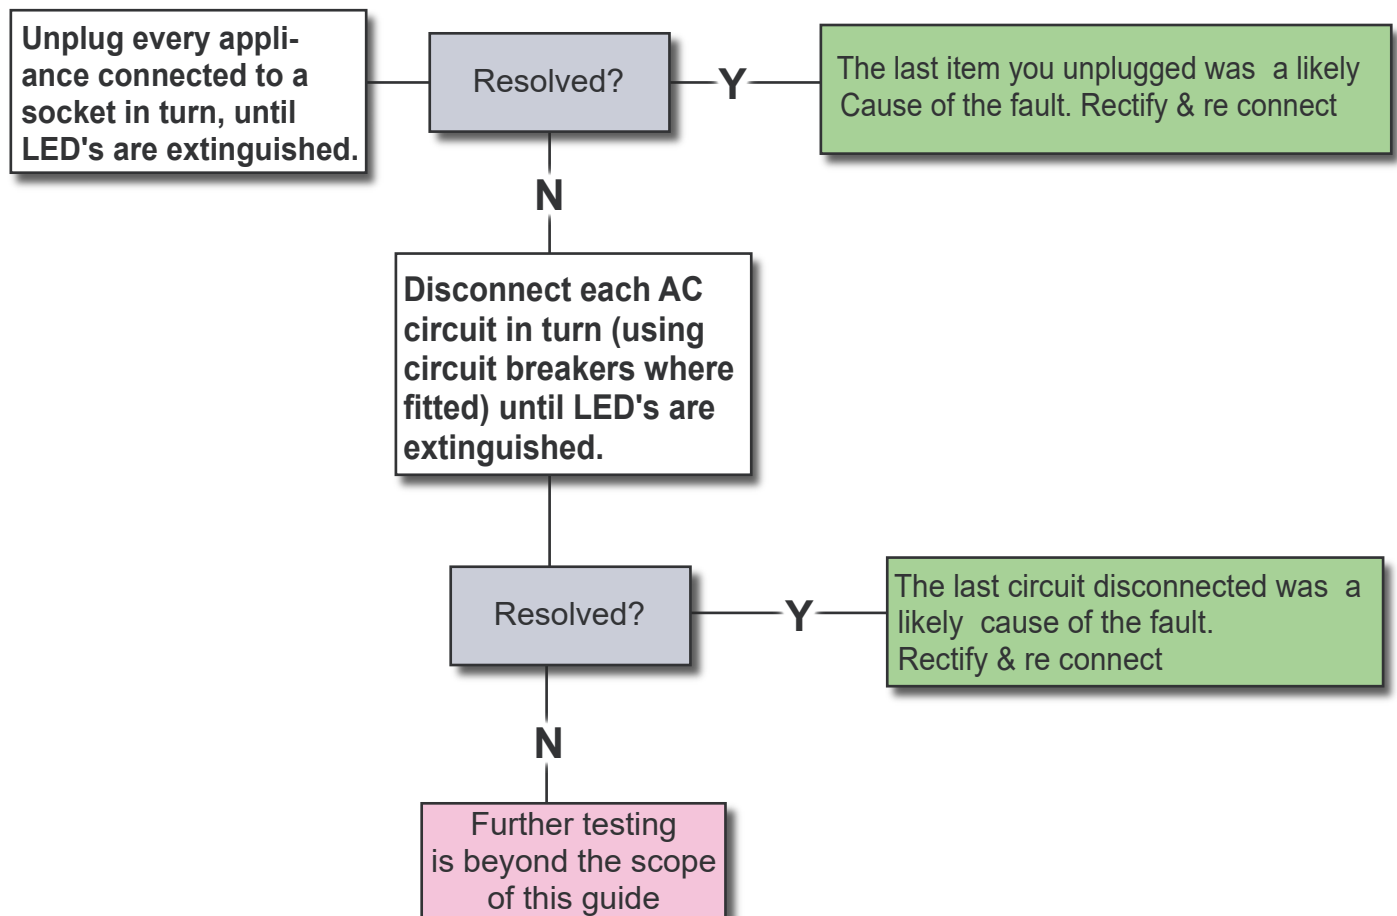
BOTH LEDs glowing

This indicates a possibility of AC (mains voltage) leakage. Proceed with great care. Danger of electrical shock. If in doubt, please consult a qualified electrician.
