Fitting Instructions

Galvanic Isolator Gi120/S/LP

The Gi120/S/LP Galvanic Isolator is intended to prevent galvanic and stray currents from finding a circulating path through the earth connection of a shore supply (Electric hookup).

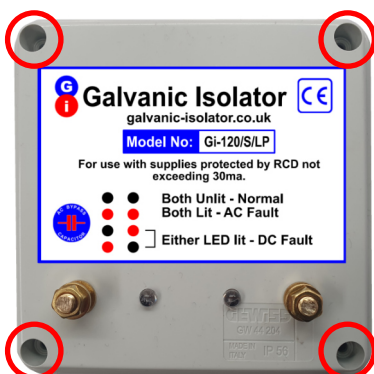
Mark through the four holes for mounting screws at positions circled in red.

Mount the isolator in your chosen location, taking care not to overtighten the screws. Alternatively, the isolator may be mounted using a suitable mastic adhesive applied to the rear.

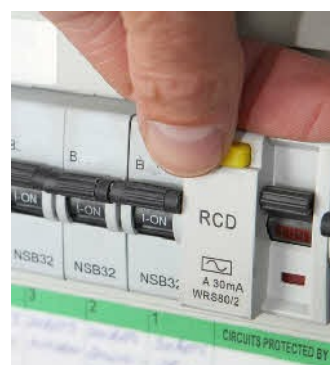
Key to Indicator Lights:

Normally, the lights should **NOT** be lit.

One light lit **RED** indicates a DC fault

Both lights lit **RED** indicates a DC fault

●	●	Both Unlit - Normal
●	●	Both Lit - AC Fault
●	●] Either LED lit - DC Fault
●	●

If any of the lights illuminate, earth leakage is present. **It is NOT a sign of a faulty isolator!** Please follow the link below, click the Instructions link, and select your model **Gi120/S/LP** and carefully follow the instructions in to the fault finding information at the end of the instructions.

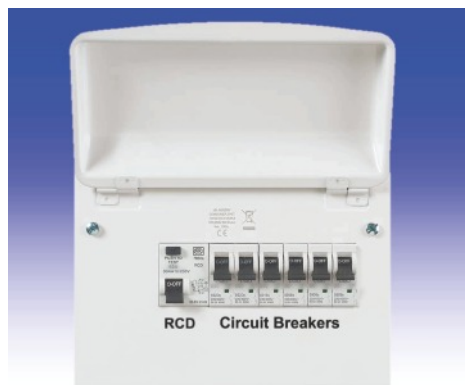
Imprinted Leakage typically occurs when equipment using a Switched Mode Power Supply Unit, (SMPSU), is connected to your system.

Pay close attention to earthing of equipment. Equipment is often installed without adequate earth bonding. Please consult the equipment's installation manual, or contact the manufacturers for more information.

In our experience, battery chargers are often the cause of imprinted leakage. CE regulations require that equipment should not create this kind of interference, but not all equipment is as "clean" as it should be.

Because of the way SMPSU's operate, some of them leak power into the boat's earth wiring. This can cause the galvanic isolators light to come on, as the isolator correctly detects the leakage.

Imprinted Leakage is traced in exactly the same way as for Mains Leakage. However, when you track the problem down to an individual appliance, it may still pass an Earth Leakage test. In that case, it's likely that the problem is Imprinted Leakage. Imprinted Leakage is often due to incorrect installation, but can also result from design or manufacturing issues.

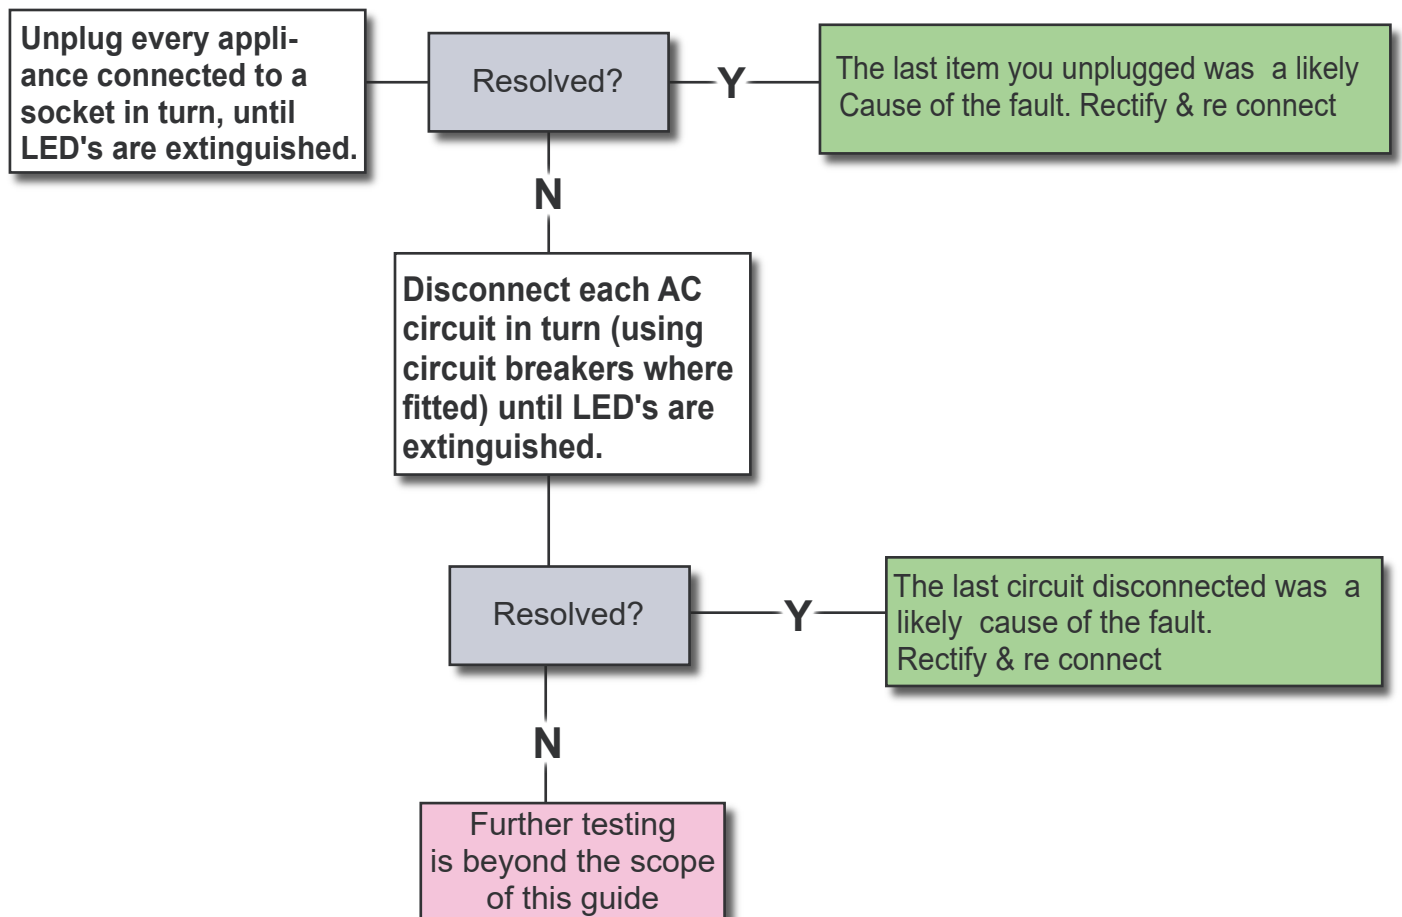
BOTH LEDs glowing

This indicates a possibility of AC (mains voltage) leakage. Proceed with great care Danger of electrical shock. If in doubt, please consult a qualified electrician.
