Galvanic Isolator

Gi50/16/SA

Instruction Leaflet

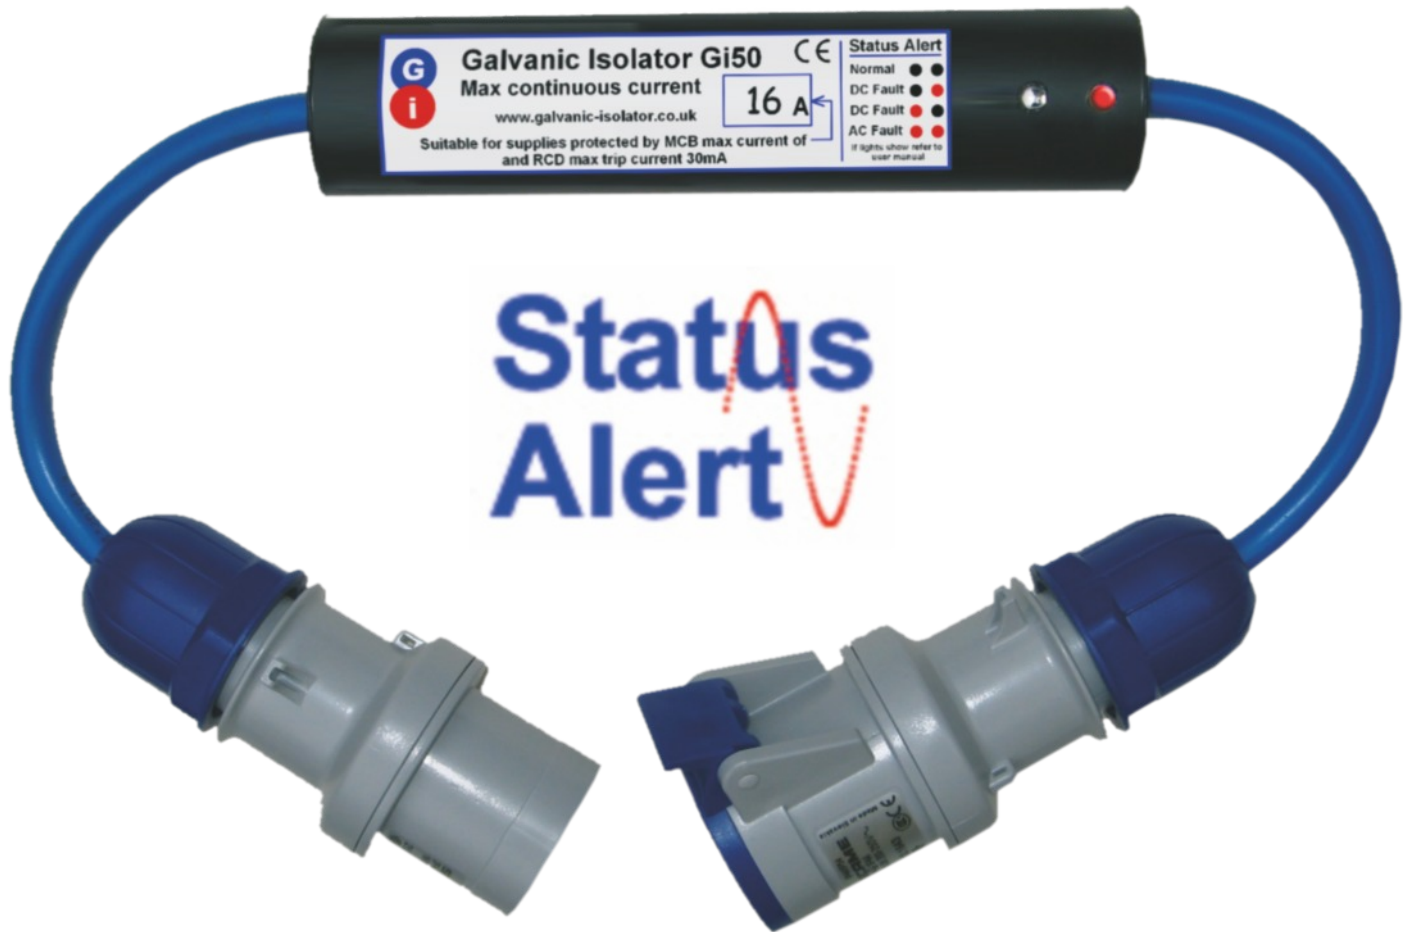
To prevent water ingress, before installation, and periodically, check Gland Nuts on both ends for tightness (Blue in photo). They should be as tight as possible **USING HAND FORCE ONLY.**

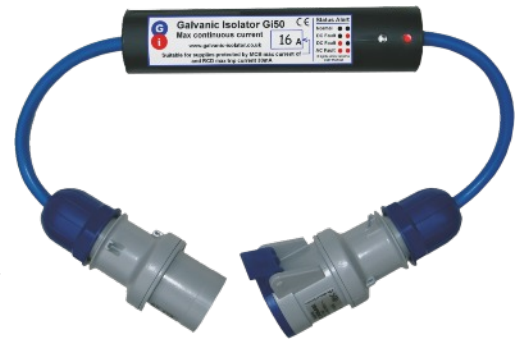
The Galvanic Isolator simply connects to EITHER end of your shore line. It can be connected either at the boat end or the shore end. Both options work equally well. Ensure that no ground connections on the vessel bypass the Galvanic isolator.

- 1) Switch off the electricity supply at the shore supply.
- 2) Unplug the shore line from whichever end you choose.
- 3) Connect the isolator to the now free end of the shore line.
- 4) Connect the free end of the isolator to the boat/shore supply.
- 5) Switch on the electricity supply at the shore supply.
- 6) Check that the RCD test button on the boat operates normally
- 7) You are now protected.

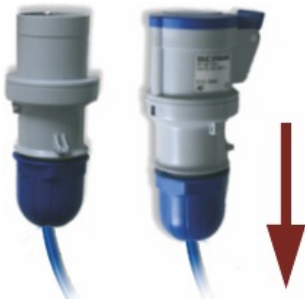
Locate your isolator where it will not be subjected to excessive heat, physical damage or water ingress, particularly the plug & socket. (Rain is acceptable - immersed or in running water is not).

When installed, to avoid water ingress, we strongly advise that the cable entries to the plug & socket should point downwards

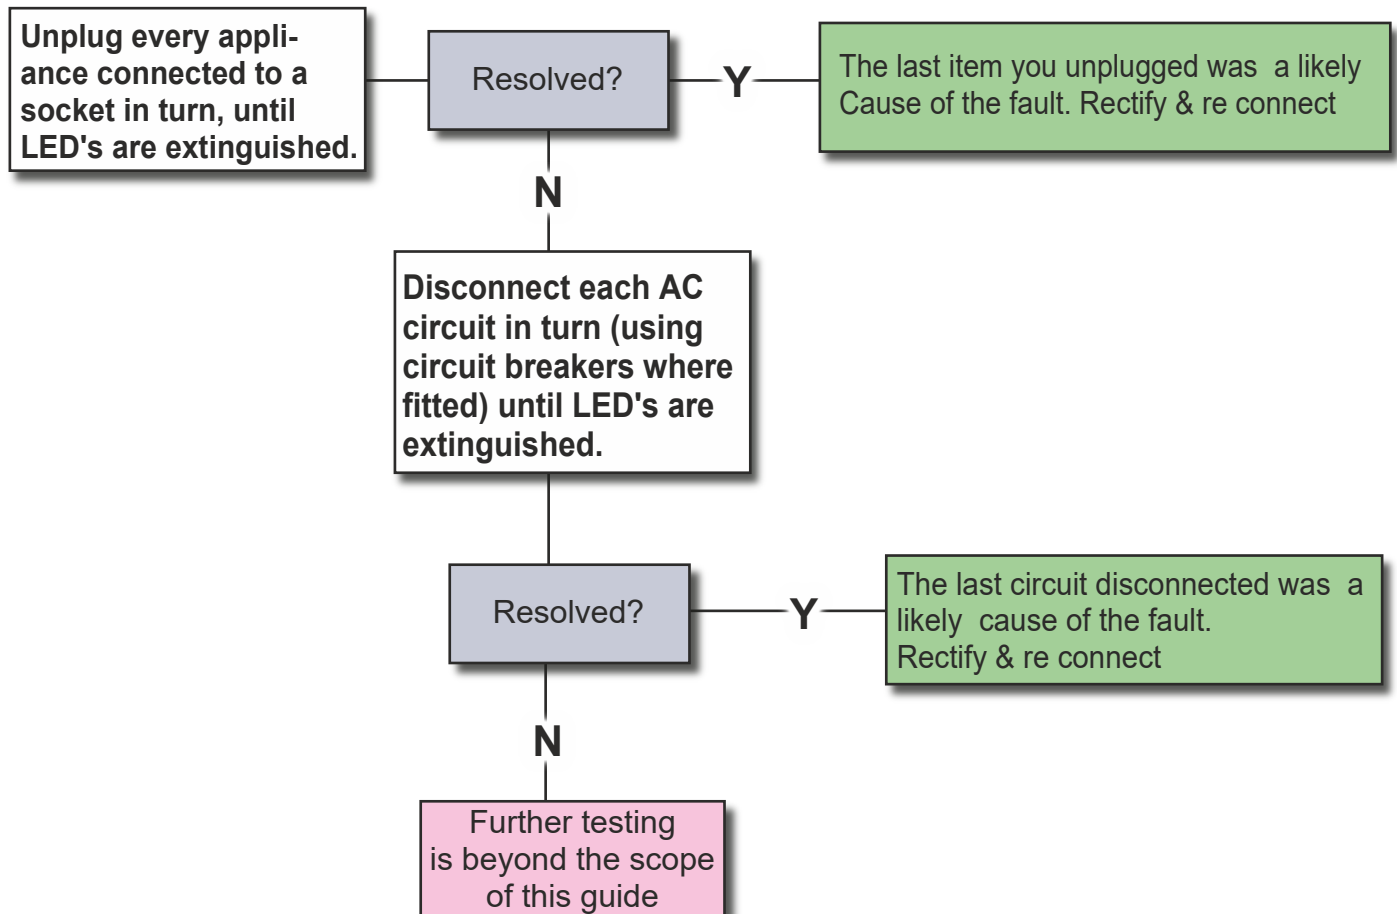
BOTH LEDs glowing

This indicates a possibility of AC (mains voltage) leakage. Proceed with great care. Danger of electrical shock. If in doubt, please consult a qualified electrician.
