## Galvanic Isolator Gi-120/A Gi-120/BK

# Instructions

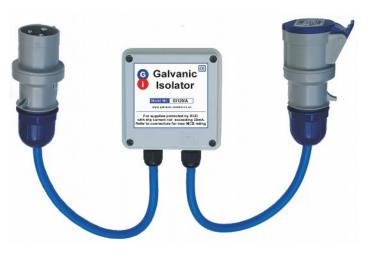
### Model Gi-120/A >>

### << Model Gi-120/BK

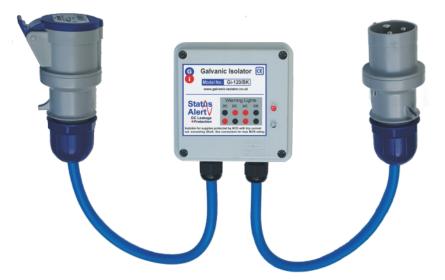
To open the connectors, please press clip (see photo), and twist connector body halves in opposite directions.

**IMPORTANT:** To prevent water ingress, before installation, and

periodically, check Gland Nuts on both cable ends for tightness (Blue in photo).

Gland Nuts should be as tight as possible USING HAND FORCE ONLY.

Isolators may be supplied with the connectors either way around. If you wish to change them this is permissible. Simply interchange the connectors, paying attention to polarity. Please ensure connecting screws and gland nuts are tight.

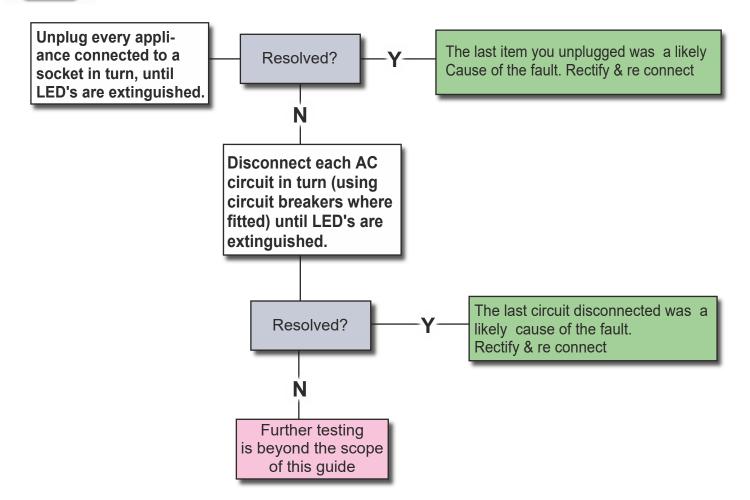
#### **BOTH LEDs glowing**

This indicates a possibility of AC (mains voltage) leakage. Proceed with great care Danger of electrical shock. If in doubt, please consult a qualified electrician.

Both Lights ON: If both lights are ON, this indicates AC leakage, usually from the mains wiring or a connected appliance. AC leakage can be a danger to life. Please see instructions for help in rectifying the problem.
