Installation Guide

Galvanic Isolator Gi120/S/SA

The Gi120/S/SA is designed for installations connected to shore supplies protected by an RCD with a trip current not exceeding 30mA.

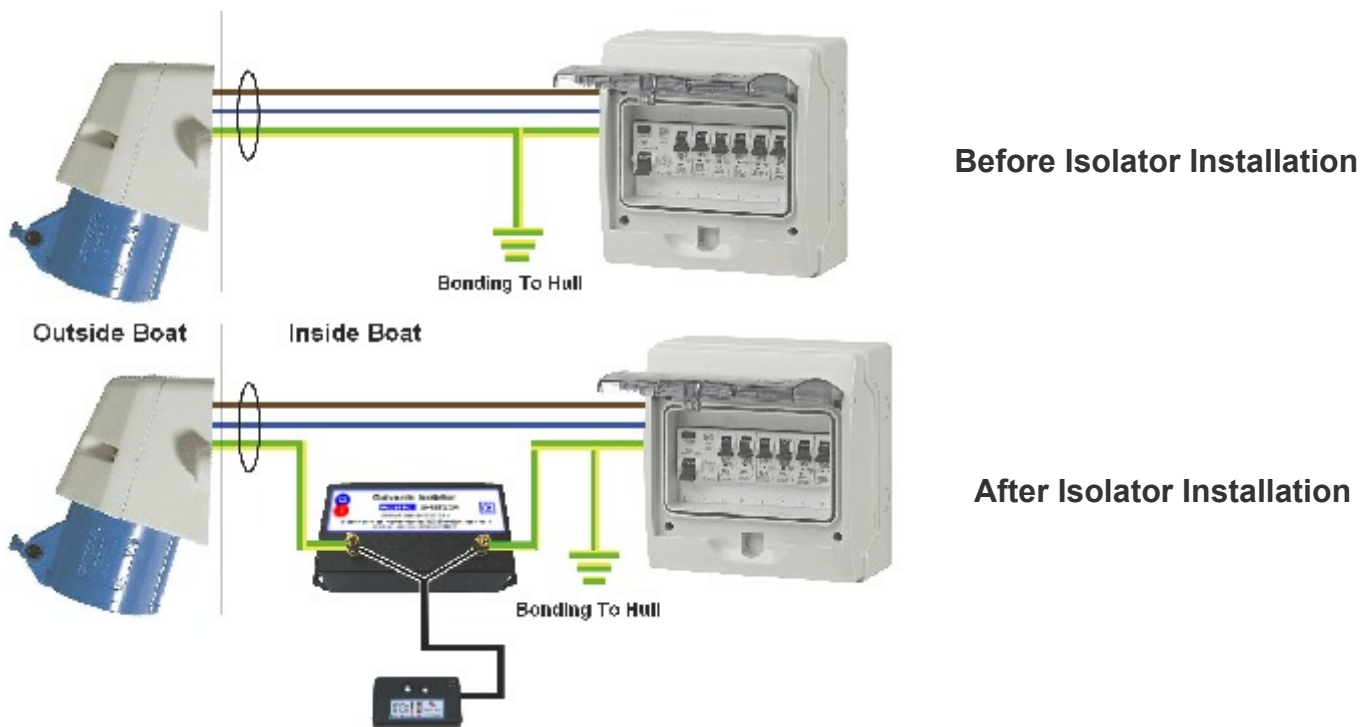
- 1) Disconnect the boat from the shore supply, and ensure that any invertors/generators etc are switched off. Please refer to the “before & after” diagram below.

- 2) Disassemble the power input connection attached to the boat, and locate the EARTH terminal. This will normally have a green or green/yellow cable connected to it. It is the LONGEST pin in the connector.

- 3) Disconnect that cable, and route it inside the boat to the place where the isolator will be located.

(If there are several wires in the terminal, they must ALL be routed to the same place and connected to the same terminal of the isolator. This is CRUCIAL to ensure that the earth bonding is retained, and that your isolator works as intended). Label the cable(s) so that they can be identified later.

- 4) Connect a new cable from the earth terminal of the power input connection, and route it inside the boat to the place where the isolator will be located. This cable should have a cross sectional area of at least 2.5mm². Label the cable so it can be identified later.

- 5) Having fixed the isolator, connect the single cable to one of the terminals on the isolator (either terminal can be used).

- 6) Connect the remaining cable(s) to the other terminal of the isolator. Do not tighten yet.

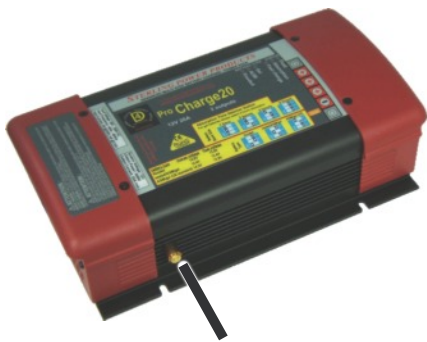
Earth bonding point

Pay close attention to earthing of equipment. Equipment is often installed without adequate earth bonding. Please consult the equipment's installation manual, or contact the manufacturers for more information.

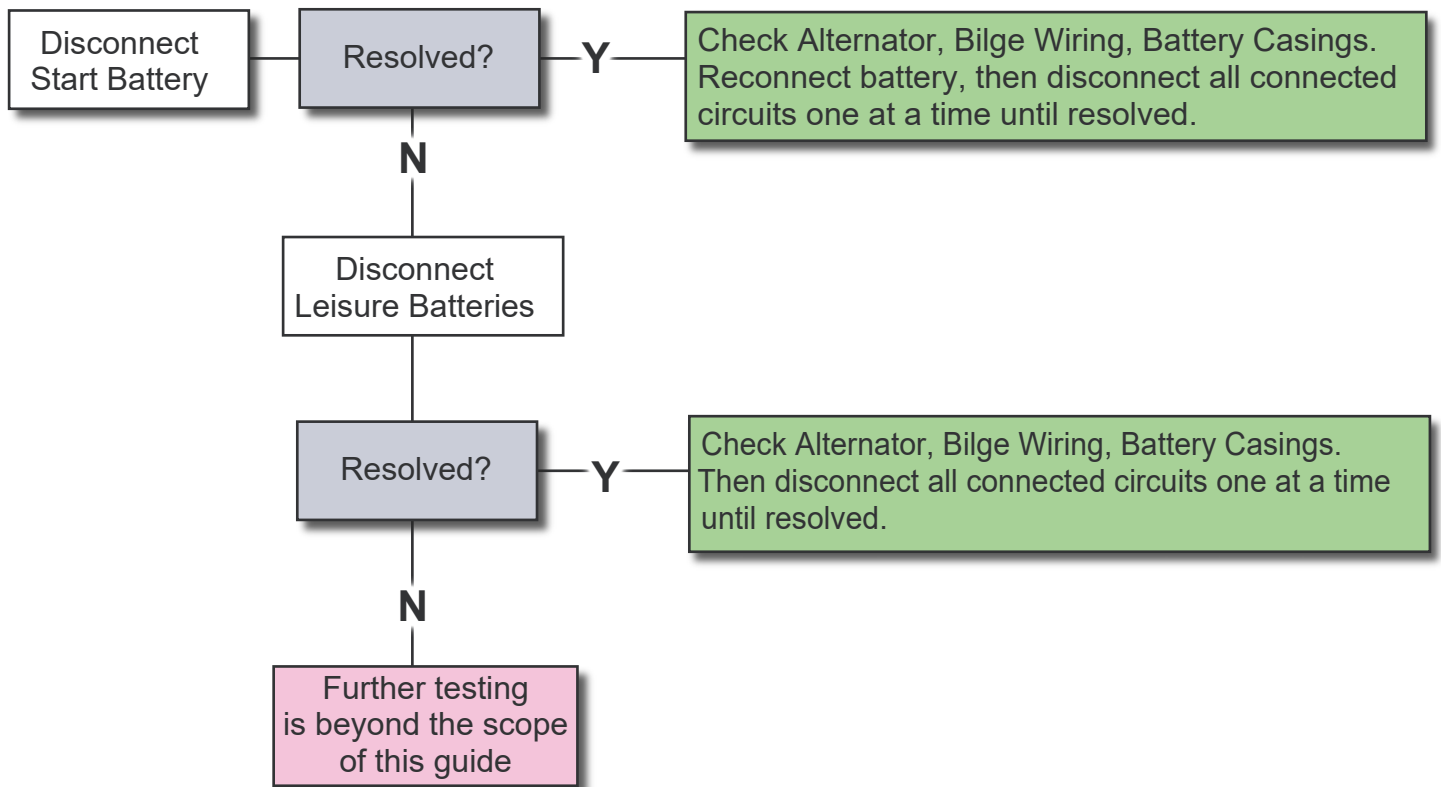
ONE (either) LED glowing

One Light ON: If either of the lights are on, it indicates DC leakage. This can cause severe corrosion to your boat. Our instructions give clear basic advice on how to resolve the problem.

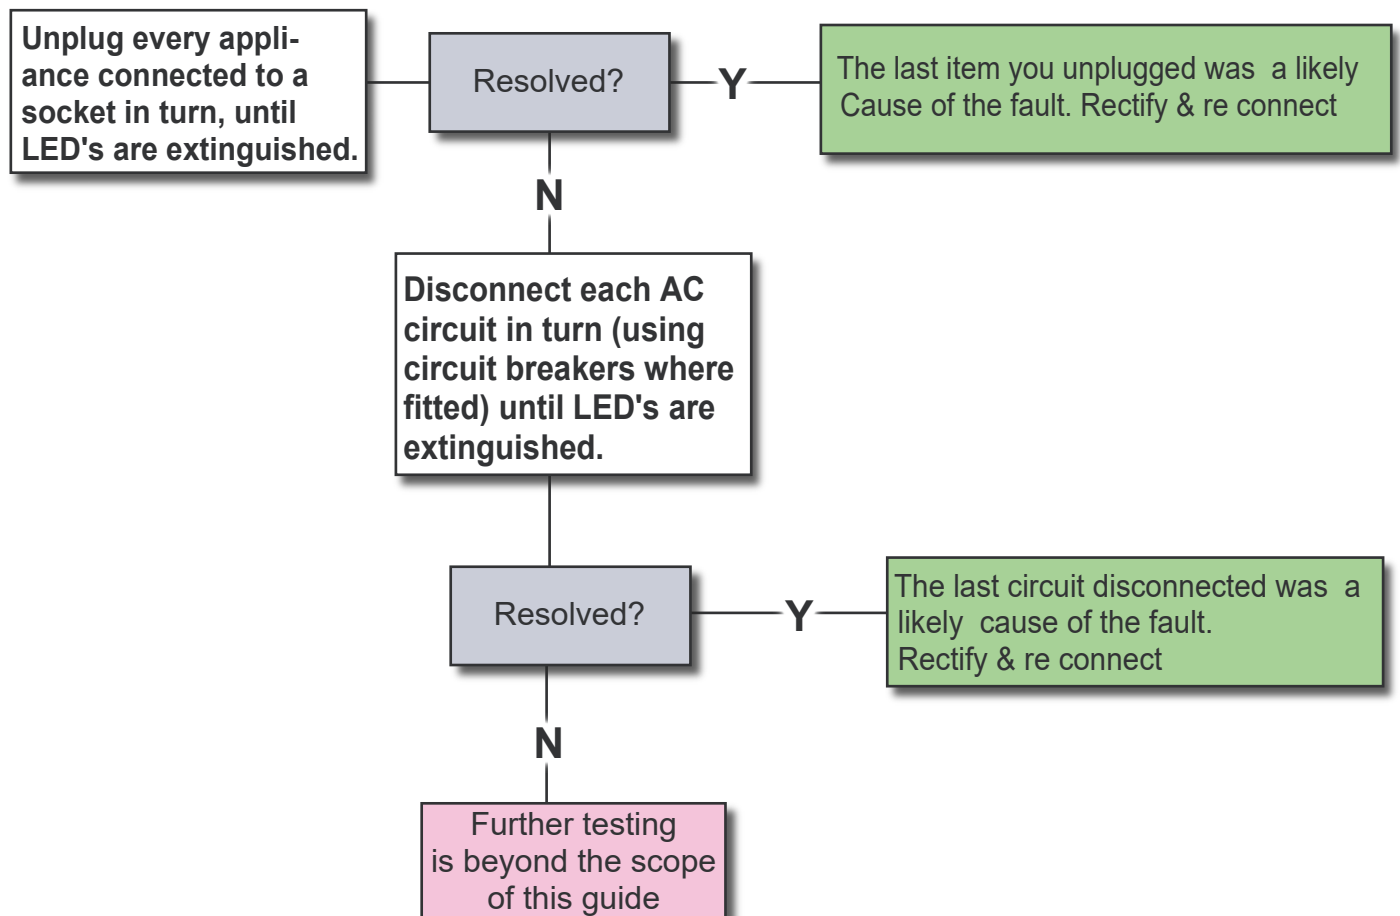
BOTH LEDs glowing

This indicates a possibility of AC (mains voltage) leakage. Proceed with great care. Danger of electrical shock. If in doubt, please consult a qualified electrician.

Both Lights ON: If both lights are ON, this indicates AC leakage, usually from the mains wiring or a connected appliance. AC leakage can be a danger to life. Please see instructions for help in rectifying the problem.
