Installation Guide

Galvanic Isolator Gi50/32/S/SA - 120a Surge Current

Gi50/32/S/SA

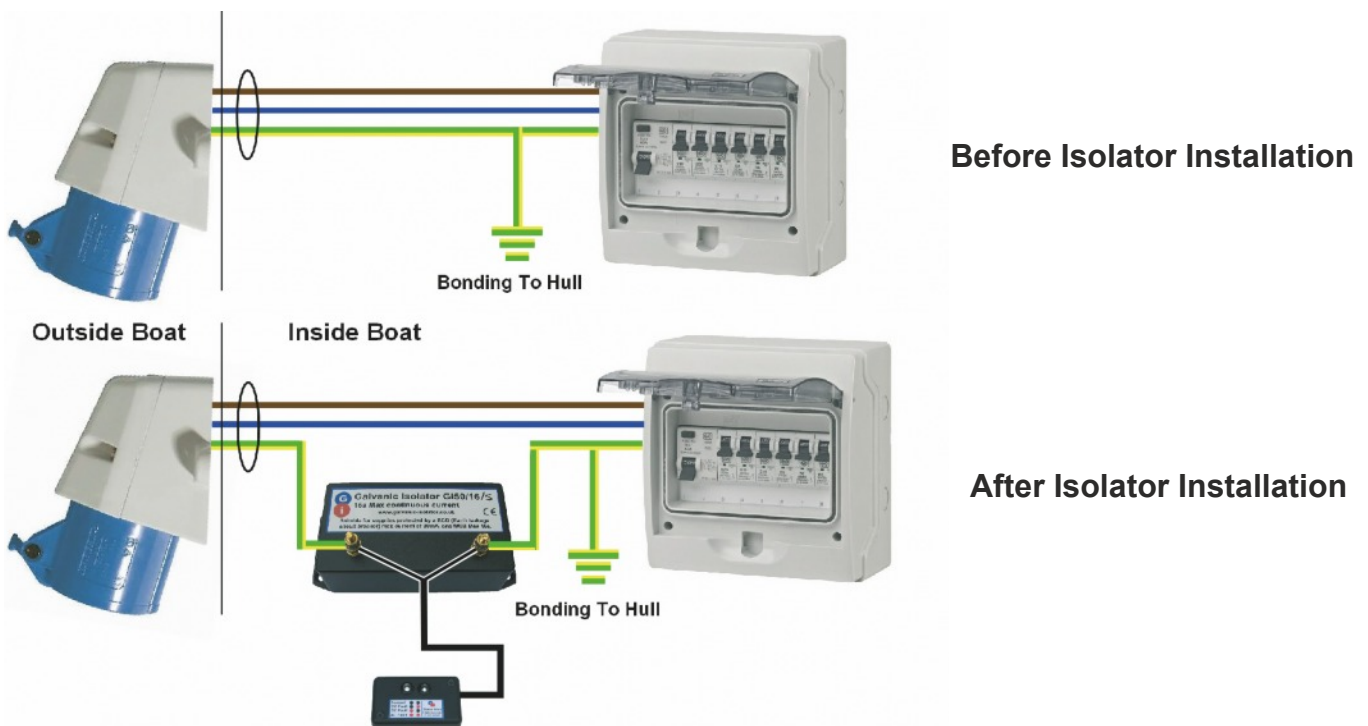
- 1) Disconnect the boat from the shore supply, and ensure that any invertors/generators etc are switched off. Please refer to the “before & after” diagram below.

- 2) Disassemble the power input connection attached to the boat, and locate the EARTH terminal. This will normally have a green or green/yellow cable connected to it. It is the LONGEST pin in the connector.

- 3) Disconnect that cable, and route it inside the boat to the place where the isolator will be located.

(If there are several wires in the terminal, they must ALL be routed to the same place and connected to the same terminal of the isolator. This is CRUCIAL to ensure that the earth bonding is retained, and that your isolator works as intended). Label the cable(s) so that they can be identified later.

- 4) Connect a new cable from the earth terminal of the power input connection, and route it inside the boat to the place where the isolator will be located. This cable should have a cross sectional area of at least 2.5mm². Label the cable so it can be identified later.

- 5) Having fixed the isolator, connect the single cable to one of the terminals on the isolator (either terminal can be used).

- 6) Connect the remaining cable(s) to the other terminal of the isolator. Do not tighten yet.

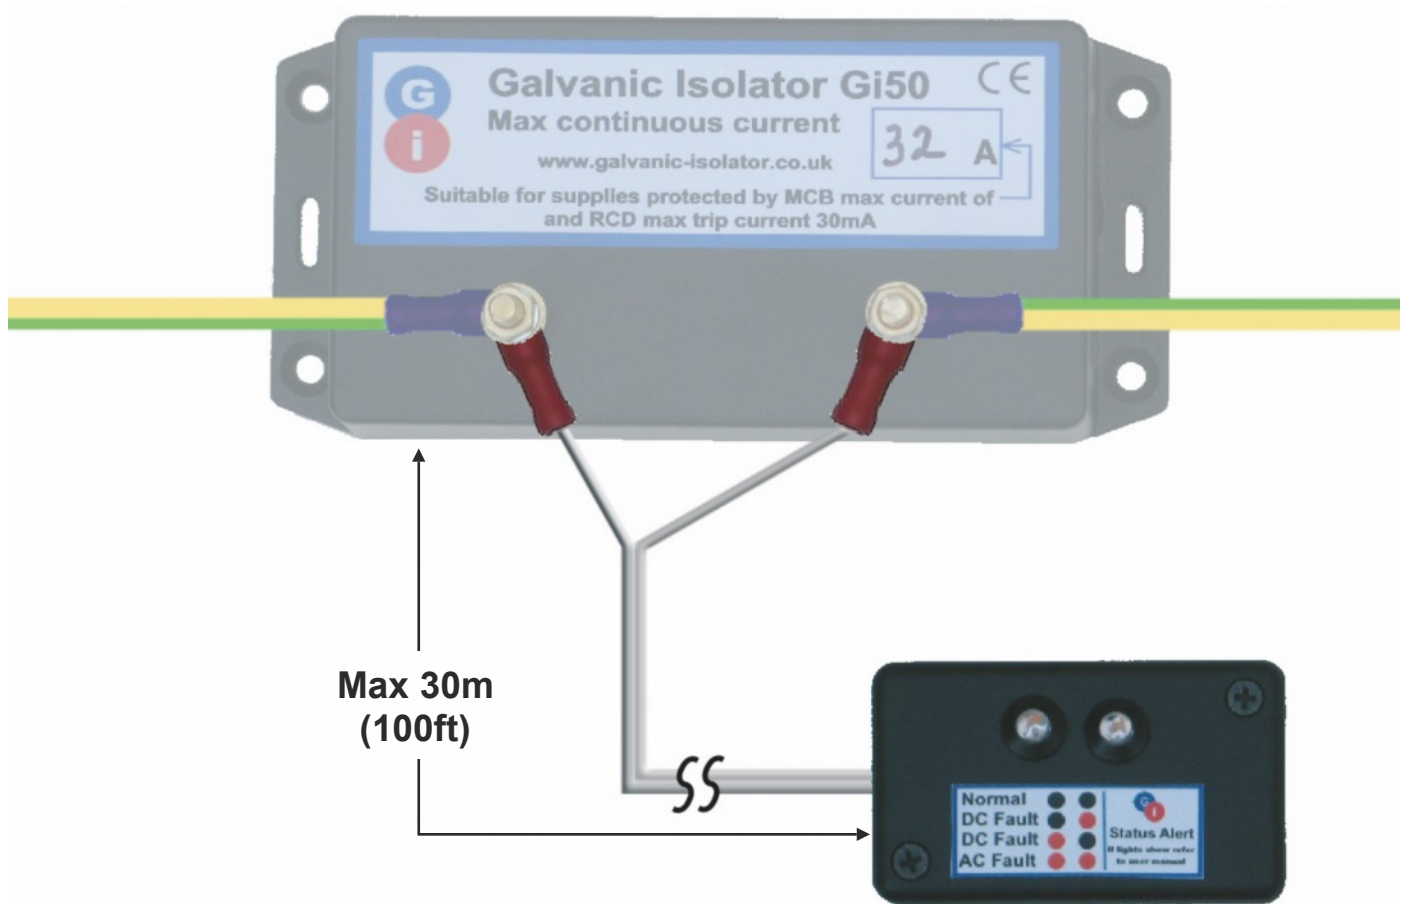
- 10) Connect the terminals on the end of the Remote Indicator connecting cable to the terminals on the Isolator. If your isolator has a third, (and smaller) terminal, it should not be connected to anything.
- 11) You should now tighten the connections to the isolator, taking care not to over tighten.
- 12) The power may now be reconnected.

13) If any of the lights illuminate, earth leakage is present. **It is NOT a sign of a faulty isolator!** Please follow the link below and refer to the fault finding information.

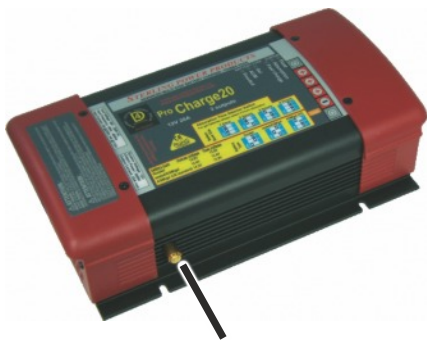
Earth bonding point

Pay close attention to earthing of equipment. Equipment is often installed without adequate earth bonding. Please consult the equipment's installation manual, or contact the manufacturers for more information.

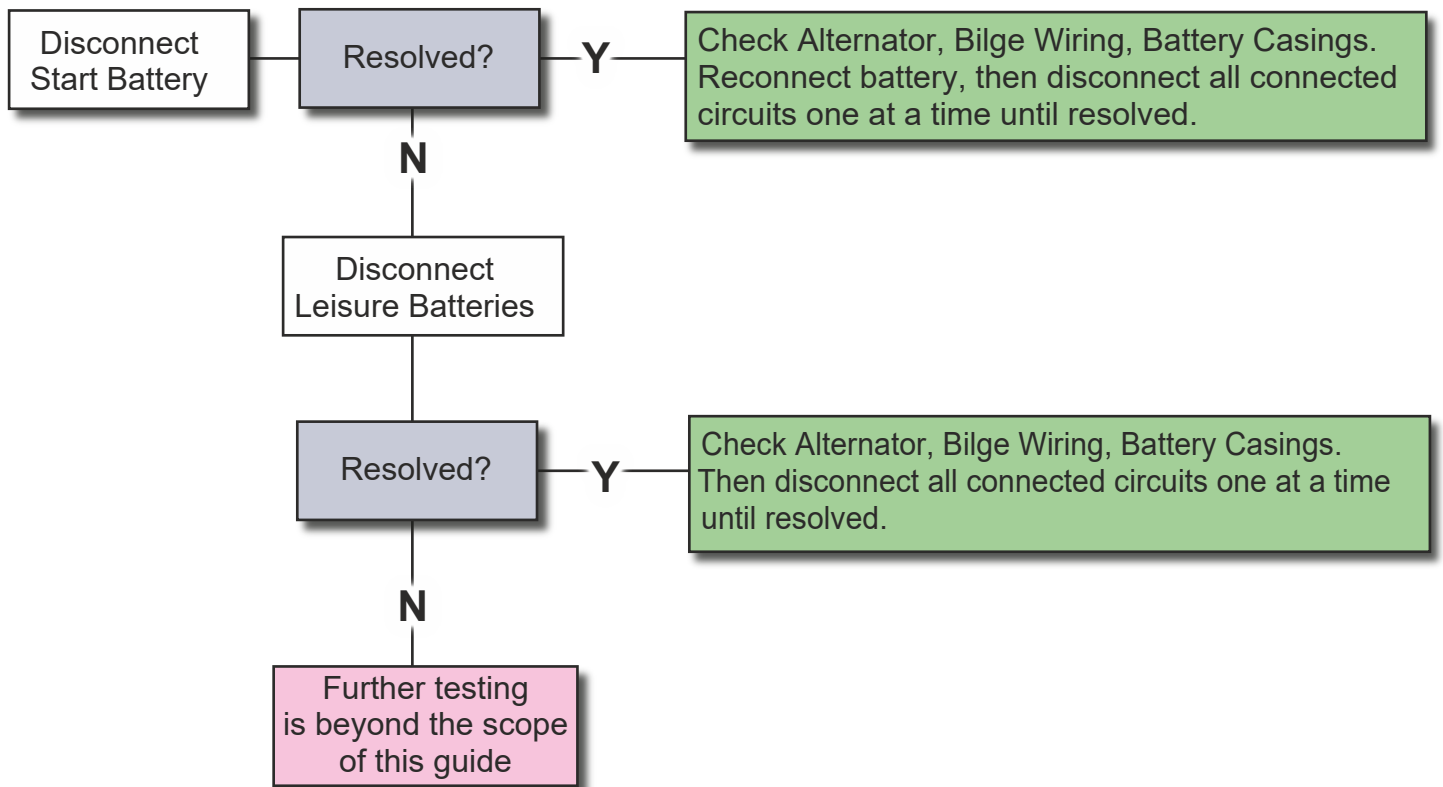
ONE (either) LED glowing

One Light ON: If either of the lights are on, it indicates DC leakage. This can cause severe corrosion to your boat. Our instructions give clear basic advice on how to resolve the problem.

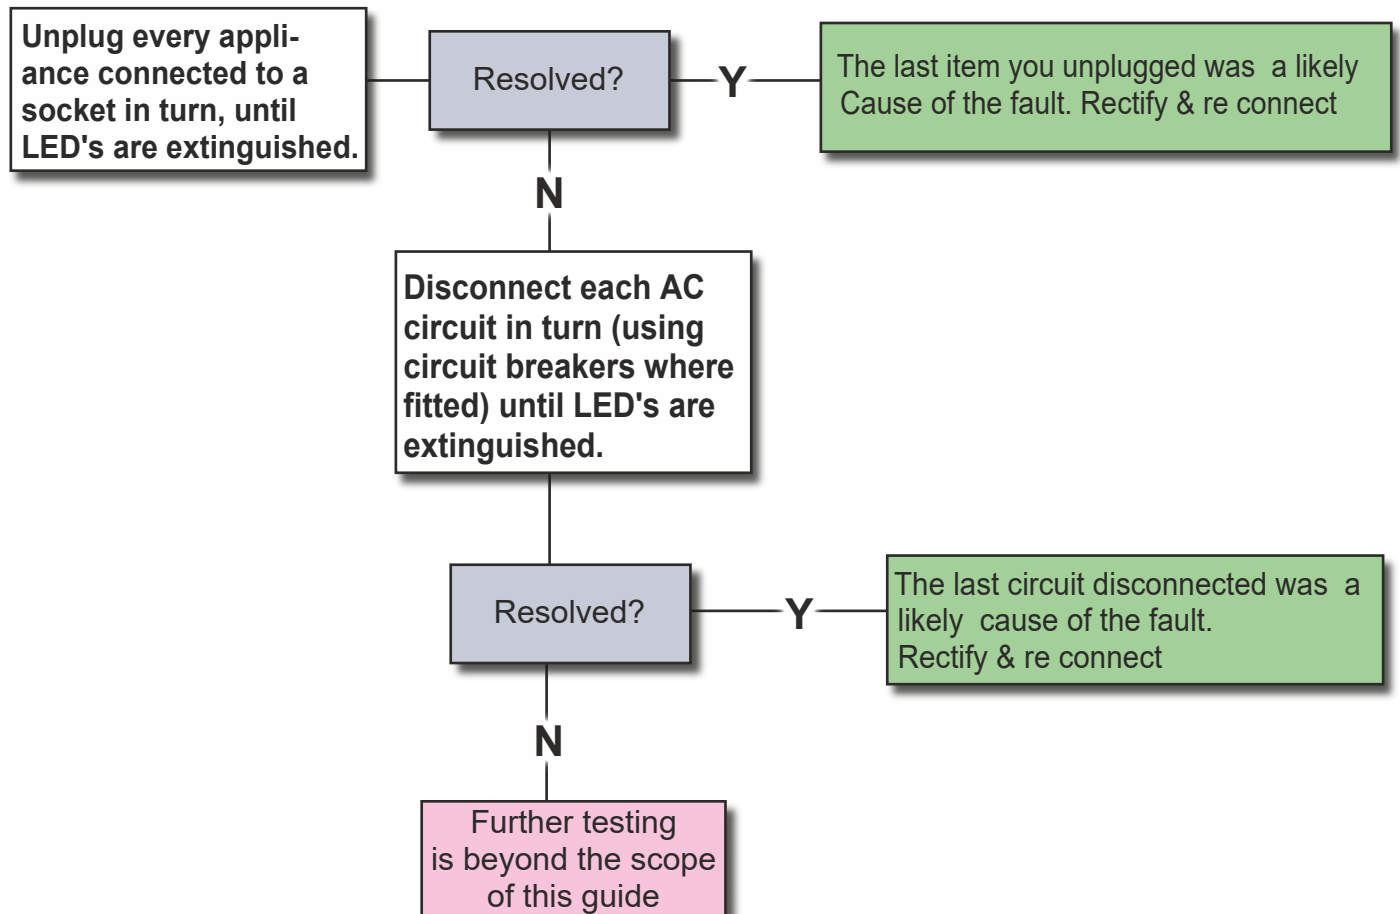
BOTH LEDs glowing

This indicates a possibility of AC (mains voltage) leakage. Proceed with great care. Danger of electrical shock. If in doubt, please consult a qualified electrician.

Both Lights ON: If both lights are ON, this indicates AC leakage, usually from the mains wiring or a connected appliance. AC leakage can be a danger to life. Please see instructions for help in rectifying the problem.

If both lights are illuminated on your galvanic isolator, you have AC earth leakage. **You do NOT have a faulty isolator.** In fact, your isolator is alerting you to a potentially dangerous situation that you may not previously have been aware of.
