Installation Guide

Galvanic Isolator Gi120/S/SA

Galvanic Isolator

Instruction Leaflet

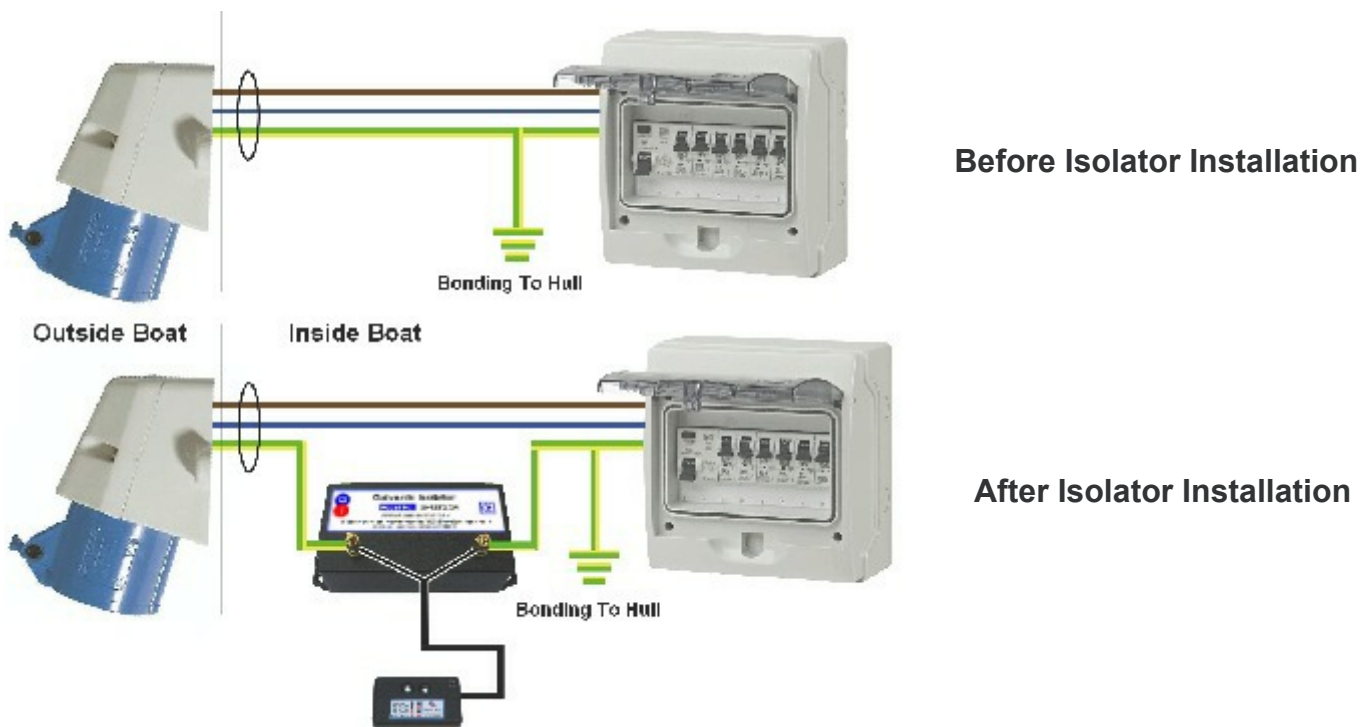
- 1) Disconnect the boat from the shore supply, and ensure that any invertors/generators etc are switched off. Please refer to the “before & after” diagram below.

- 2) Disassemble the power input connection attached to the boat, and locate the EARTH terminal. This will normally have a green or green/yellow cable connected to it. It is the LONGEST pin in the connector.

- 3) Disconnect that cable, and route it inside the boat to the place where the isolator will be located.

(If there are several wires in the terminal, they must ALL be routed to the same place and connected to the same terminal of the isolator. This is CRUCIAL to ensure that the earth bonding is retained, and that your isolator works as intended). Label the cable(s) so that they can be identified later.

- 4) Connect a new cable from the earth terminal of the power input connection, and route it inside the boat to the place where the isolator will be located. This cable should have a cross sectional area of at least 2.5mm². Label the cable so it can be identified later.

- 5) Having fixed the isolator, connect the single cable to one of the terminals on the isolator (either terminal can be used).

- 6) Connect the remaining cable(s) to the other terminal of the isolator. Do not tighten yet.

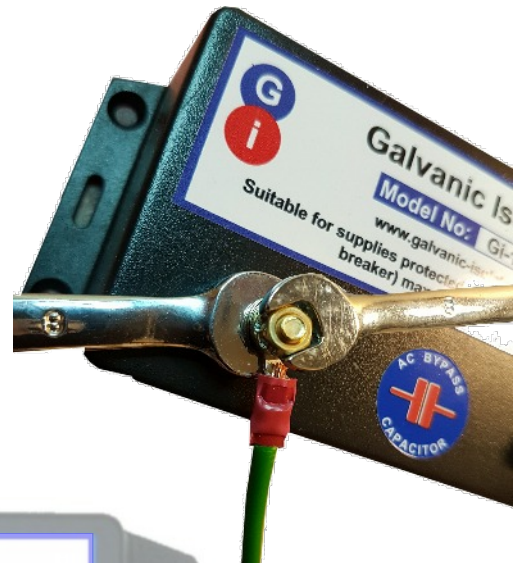
11) You should now tighten the connections to the isolator, **taking care not to over tighten.** Use a spanner to prevent the lower nut from turning, whilst carefully tightening the upper nut.

See image to right.

**DO NOT
OVER TIGHTEN**

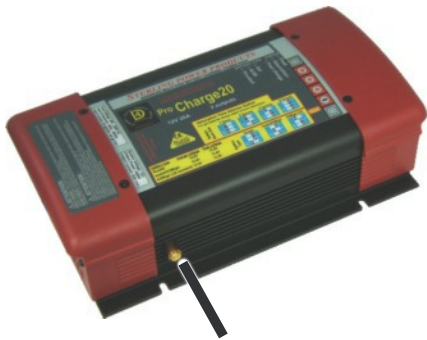
Earth bonding point

Pay close attention to earthing of equipment. Equipment is often installed without adequate earth bonding. Please consult the equipment's installation manual, or contact the manufacturers for more information.

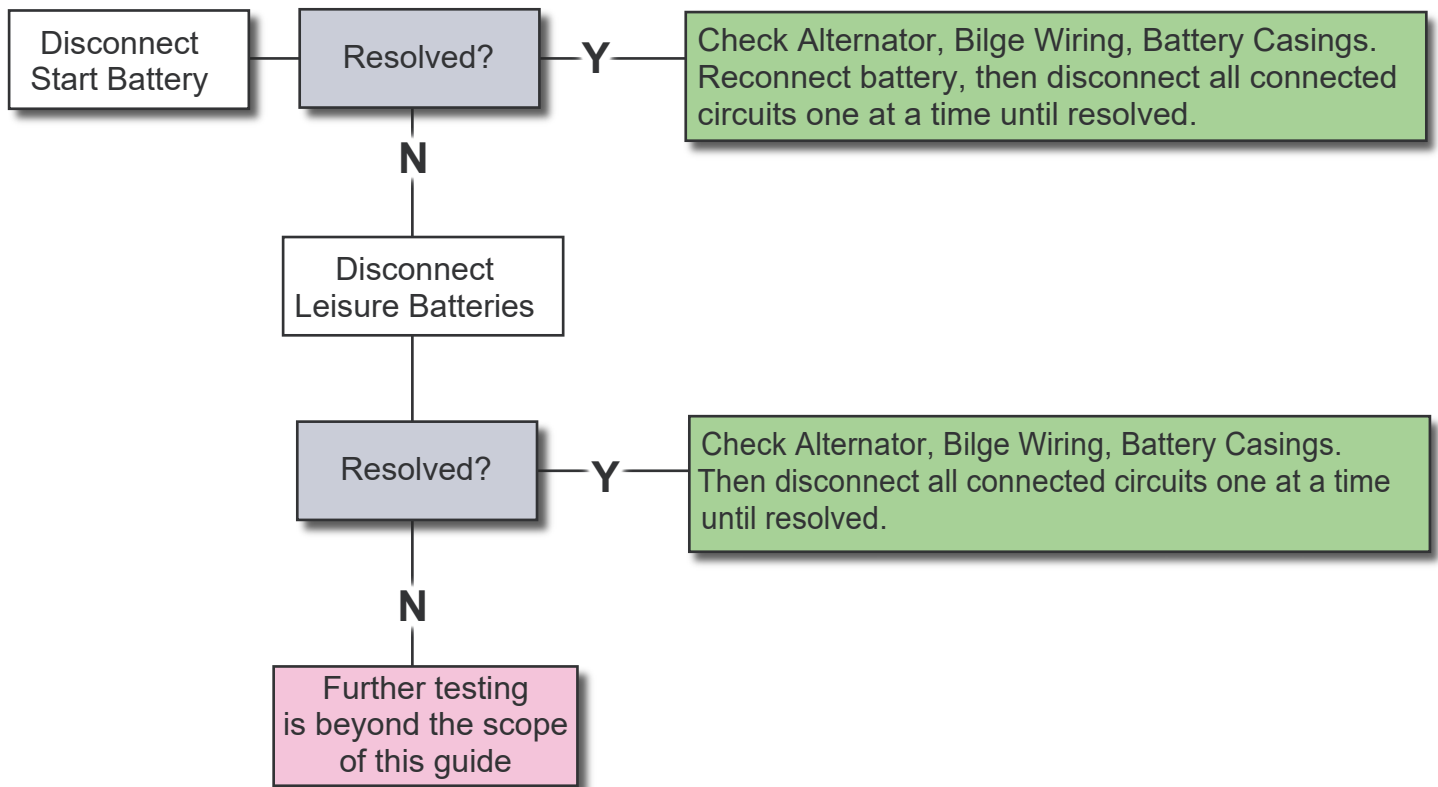
ONE (either) LED glowing

One Light ON: If either of the lights are on, it indicates DC leakage. This can cause severe corrosion to your boat. Our instructions give clear basic advice on how to resolve the problem.

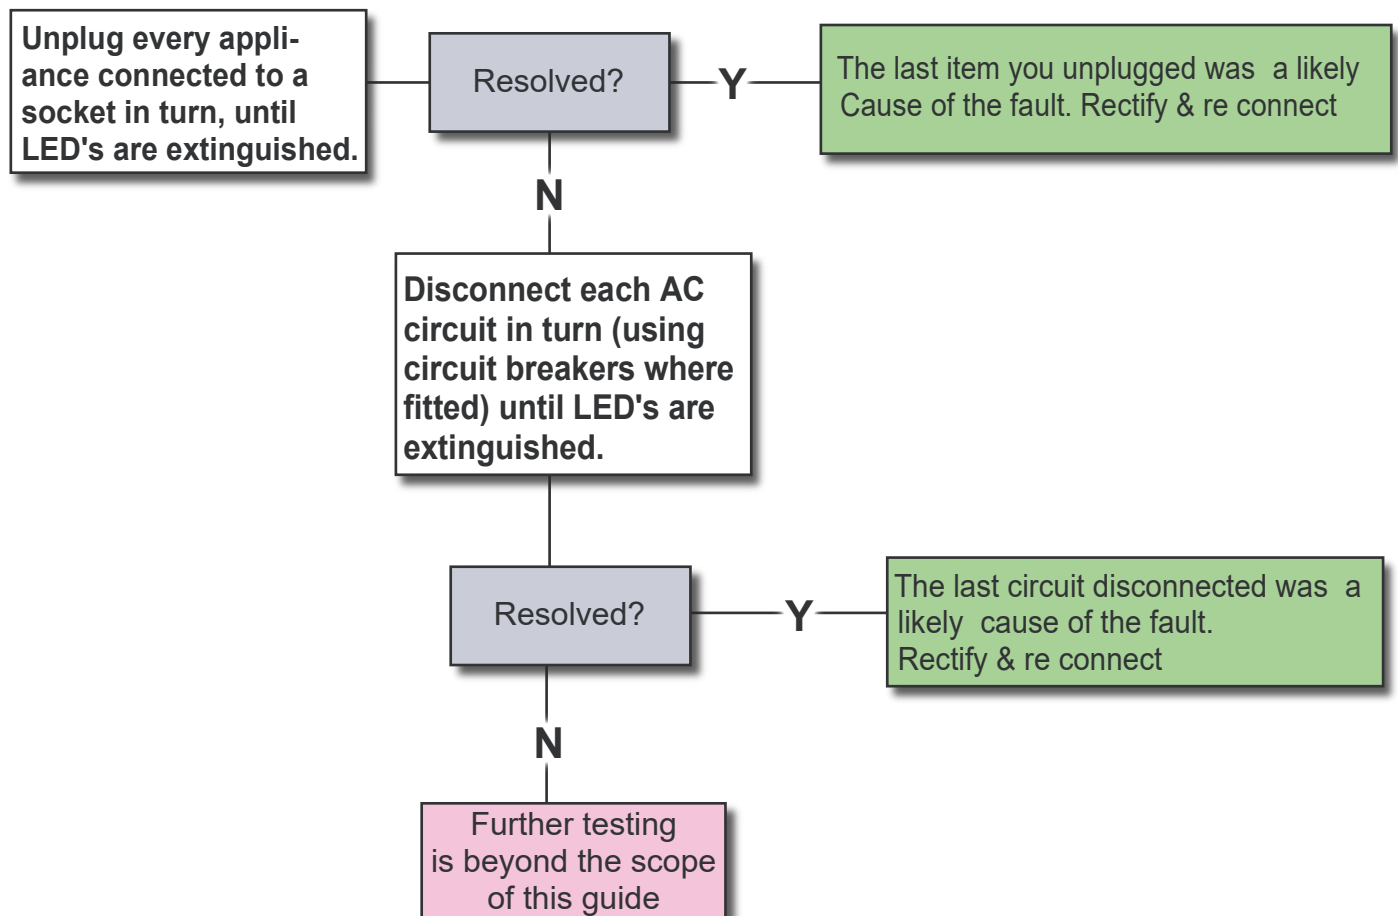
BOTH LEDs glowing

This indicates a possibility of AC (mains voltage) leakage. Proceed with great care. Danger of electrical shock. If in doubt, please consult a qualified electrician.

Both Lights ON: If both lights are ON, this indicates AC leakage, usually from the mains wiring or a connected appliance. AC leakage can be a danger to life. Please see instructions for help in rectifying the problem.

If both lights are illuminated on your galvanic isolator, you have AC earth leakage. **You do NOT have a faulty isolator.** In fact, your isolator is alerting you to a potentially dangerous situation that you may not previously have been aware of.
