Installation Guide

Galvanic Isolator Gi120/S/SA

The Gi120/S/SA is designed for installations connected to shore supplies protected by an RCD with a trip current not exceeding 30mA.

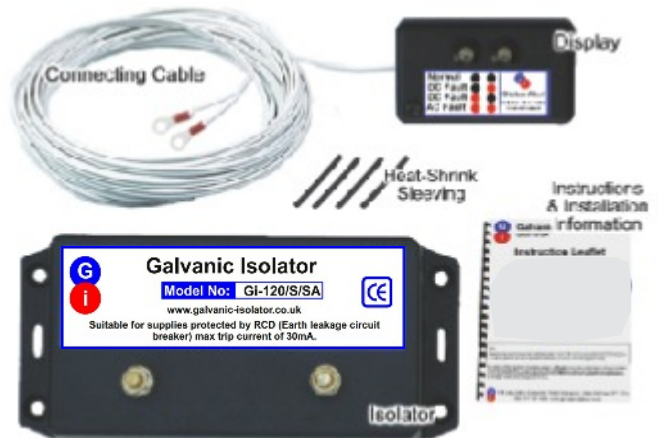
Strip the ends by about 1cm, twist the wires tightly together, then insulate using the heat shrink tubing supplied. Offset the joints of the two cores by about 3 centimetres, as shown in the image. Ideally the joint should be soldered, but twisting tightly is normally sufficient.

If it is desired to lengthen the connecting cable, we recommend that you use a multi stranded cable of similar type to that fitted. The cable may be lengthened or shortened by cutting the cable, and re-joining it.

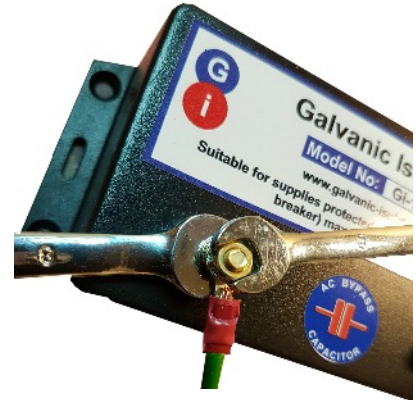
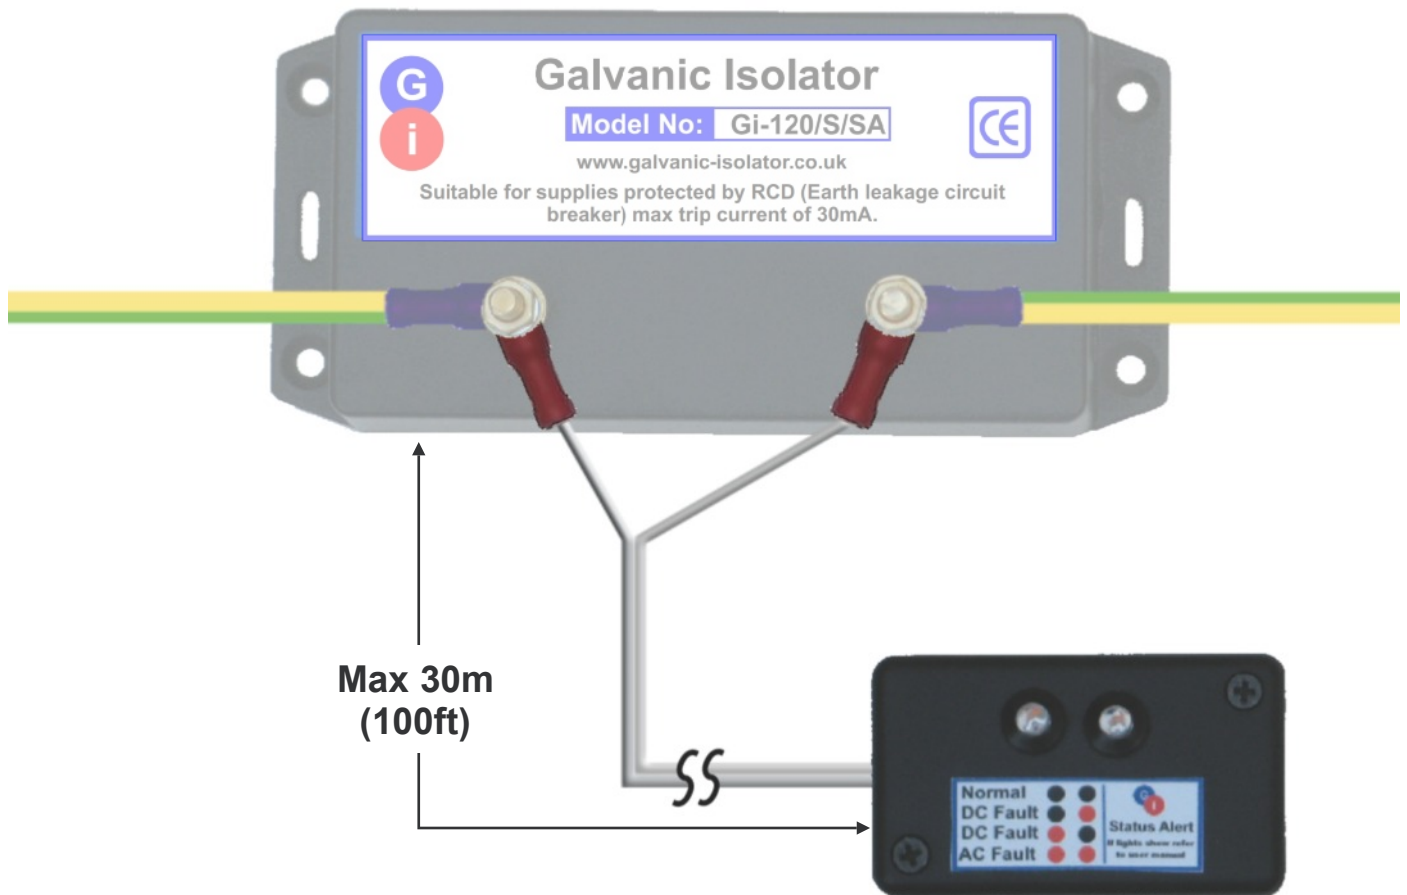
- 10) Connect the terminals on the end of the Remote Indicator connecting cable to the terminals on the Isolator.
- 11) You should now tighten the connections to the isolator, taking care not to over tighten. **Use a spanner to hold the lower nut whilst tightening the upper nut** (See Picture).
- 12) The power may now be reconnected.

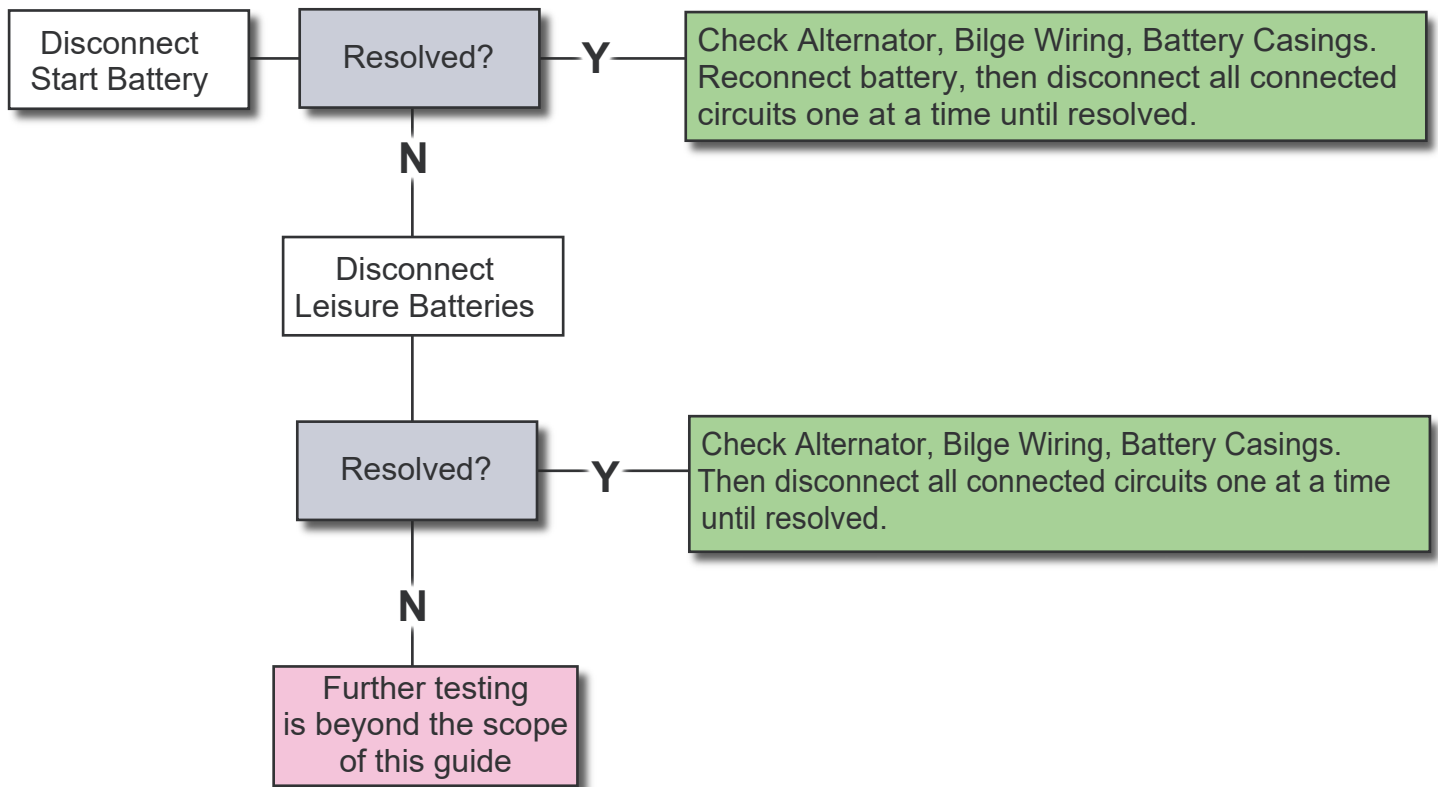
ONE (either) LED glowing

One Light ON: If either of the lights are on, it indicates DC leakage. This can cause severe corrosion to your boat. Our instructions give clear basic advice on how to resolve the problem.
